# Access Compliance Report

## Public Rights-of-Way

### (Curb Ramps)

| Intersection ID: 5966 | Main Street: SUNSTONE_DR | Cross Street: STATESVILLE_RD | Location: SE |

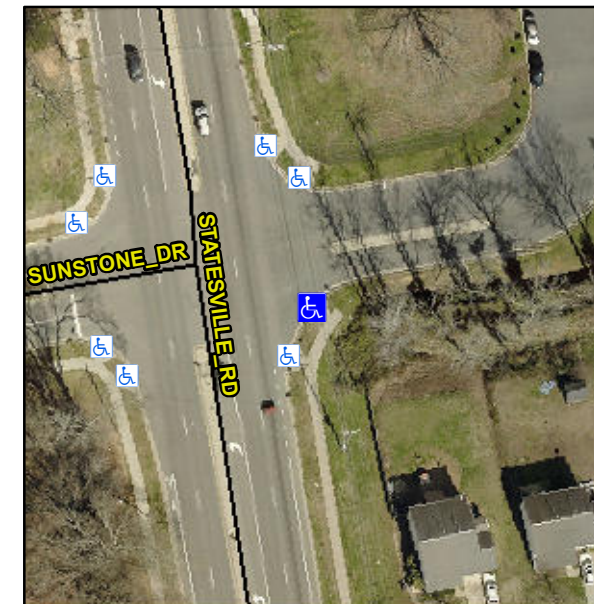
**Not Found, R304.5.1, R304.5.3**

| Compliance | Description | Data | Compliance | Description | Data |
|---|---|---|---|---|---|
| N/A | Ramp Length (in) | 105.5 | Yes | Ramp Slope (%) | 5.8 |
| No | Ramp Width (in) | 40.5 | No | Ramp XSlope (%) | 2.2 |

**Remove & Replace Entire Ramp.**

Total Cost: \$ 1850.00
