Access Compliance Report

Public Rights-of-Way

(Curb Ramps)

Intersection ID: 8630	Main Street: BRADFORD_DR	Cross Street: CANTWELL_ST	Location:	E
ADA ID: 85E83CBD2B33	Ramp Type: Directional	Initial Pass/Fail: Fail	Overall Compliance: No	Severity Score: 12.5

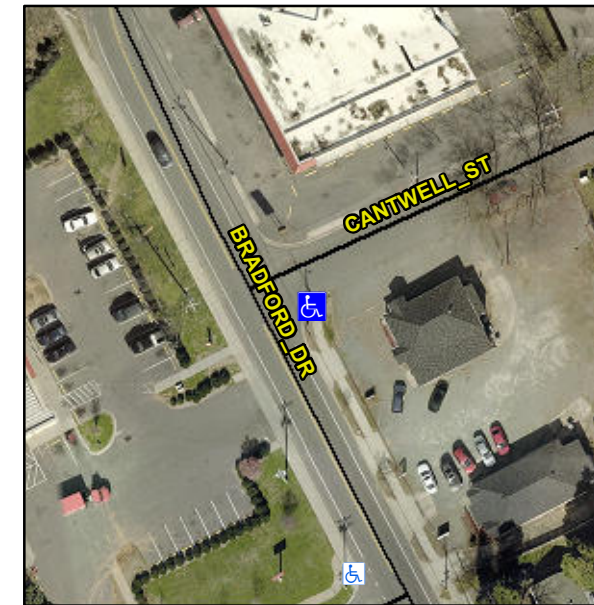
Compliance	Description	Data	Compliance	Description	Data
N/A	Ramp Length (in)	64.0	N/A	Grade Break?	N/A
Yes	Ramp Width (in)	48.0	N/A	Grade Break Slope (%)	0.0
No	Ramp Slope (%)	10.4	N/A	Grade Break XSlope (%)	0.0
Yes	Ramp XSlope (%)	2.0			
N/A	Flare Type LT	N/A	N/A	Flare Type RT	N/A
N/A	Flare Slope LT (%)	N/A	N/A	Flare Slope RT (%)	0.0
N/A	Flare Traversable LT?	N/A	N/A	Flare Traversable RT?	N/A
N/A	Landing Length (in)	0.0	N/A	DWS Provided?	N/A
N/A	Landing Width (in)	0.0	N/A	DWS Contrast?	N/A
N/A	Landing Slope (%)	0.0	N/A	DWS Length (in)	N/A
N/A	Landing X Slope (%)	0.0	N/A	DWS Full Width?	N/A
N/A	Landing Curb? (Y/N)	N/A	N/A	DWS Offset LT (in)	N/A
N/A	Shared Landing?	N/A	N/A	DWS Offset RT (in)	N/A
N/A	Gutter Ponding?	0.0	N/A	Gutter Slope (%)	N/A
N/A	Gutter Lip Ht (in)	0.0	N/A	Gutter X Slope (%)	N/A
N/A	Painted X Walk1?	No		Road Slope (%)	4.8
	X Walk 1 Direction	N/A		Road X Slope (%)	0.5
	X Walk 1 Width (in)	N/A		Clear Space?	N/A

X Walk 1 Slope (%)	4.8	N/A	Clear Space to XWalk (in)	N/A
	X Walk 1 X Slope (%)	0.5	N/A	Storm Grate/Utility Hazard?	N/A
N/A	Ramp inside XWalk1?	N/A		Storm Grate/Utility Type	
N/A	Any Obstructions?	N/A			N/A
	Obstruction Type		Yes	Surface Condition? (G/P)	Good
			N/A	Curb Slope (%)	10.7

Possible Solutions:

Remove & Replace Entire Ramp.
