# Access Compliance Report

## Public Rights-of-Way

### (Curb Ramps)

Intersection ID: 6159	Main Street: ORR_ST	Cross Street: GRAYPARK_DR	Location: NE
ADA ID: 86018E18E472	Ramp Type: Perp	Initial Pass/Fail: Pass	Overall Compliance: No
Severity Score: 0

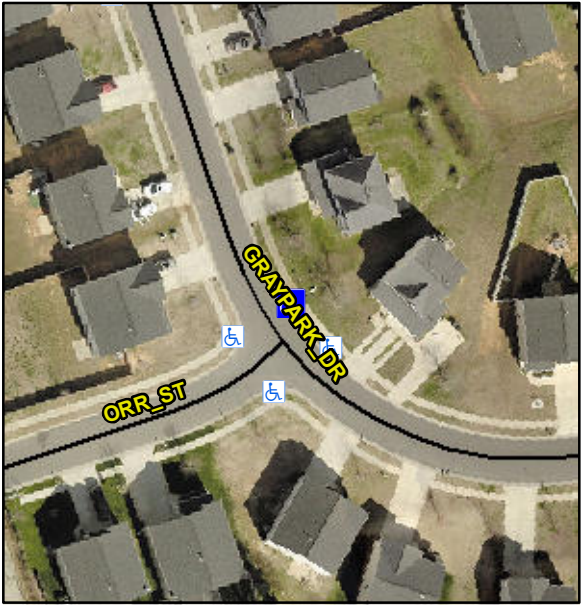
Possible Solutions:		<b>Compliance</b>	<b>Description</b>	<b>Data</b>
	<b>Remove &amp; Replace Entire Ramp.</b>		<b>Yes</b>	Ramp Length (in)	48.0
	<b>Remove &amp; Replace Gutter.</b>		<b>Yes</b>	Ramp Width (in)	48.0
			<b>N/A</b>	Flare Type LT	Sloped
			<b>N/A</b>	Flare Slope LT (%)	5.9
			<b>N/A</b>	Flare Traversable LT?	No
			<b>Yes</b>	Landing Length (in)	48.0
			<b>Yes</b>	Landing Width (in)	48.0
			<b>No</b>	Landing Slope (%)	2.5
			<b>Yes</b>	Landing X Slope (%)	0.9
Surveyor Notes:  <b>N/A</b>			<b>N/A</b>	Flare Type RT	N/A
			<b>N/A</b>	Flare Slope RT (%)	3.6
			<b>N/A</b>	Flare Traversable RT?	No
			<b>Yes</b>	DWS Provided?	Yes
			<b>Yes</b>	DWS Contrast?	Yes
			<b>Yes</b>	DWS Length (in)	24.5
			<b>Yes</b>	DWS Full Width?	Yes
			<b>No</b>	DWS Offset (in)	3.0
			<b>N/A</b>	Shared Landing?	No
			<b>Yes</b>	Gutter Ponding?	No

PROW/ADA:  <b>Not Found, R304.2.2-Perp, R304.3.2-Para, R305.2, R304.5.4</b>			<b>Yes</b>	Gutter Lip Ht (in)	0.0
			<b>N/A</b>	Painted X Walk1?	No
				X Walk 1 Direction	To W
			<b>N/A</b>	X Walk 1 Width (in)	N/A
				X Walk 1 Slope (%)	3.5
				X Walk 1 X Slope (%)	1.3
			<b>N/A</b>	Ramp inside XWalk1?	N/A
			<b>N/A</b>	Road Slope (%)	N/A
			<b>N/A</b>	Road X Slope (%)	N/A
			<b>Yes</b>	Any Obstructions?	No
Total Cost: \$ 2600.00				Obstruction Type	
			<b>N/A</b>		
			<b>Yes</b>	Surface Condition? (G/P)	Good
