14.6

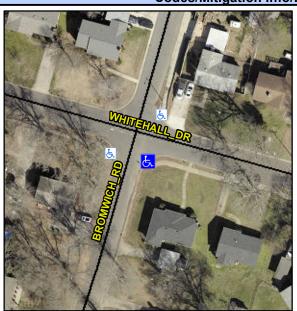
Total Cost: 3200.00

Field Measurements/Component Compliance					
Compliance Description		Data	Compliance Description		Data
N/A	Ramp Length (in)	50.0	Yes	BlendTrans Slope (%)	4.6
Yes	Ramp Width (in)	48.0	No	BlendTrans XSlope (%)	5.2
N/A	Flare Type LT	N/A	N/A	Flare Type RT	N/A
N/A	Flare Slope LT (%)	N/A	N/A	Flare Slope RT (%)	N/A
N/A	Flare Traversable LT?	N/A	N/A	Flare Traversable RT?	N/A
N/A	Landing Length (in)	N/A	N/A	DWS Provided?	N/A
N/A	Landing Width (in)	N/A	N/A	DWS Contrast?	N/A
N/A	Landing Slope (%)	N/A	N/A	DWS Length (in)	N/A
N/A	Landing X Slope (%)	N/A	N/A	DWS Full Width?	N/A
N/A	Landing Curb? (Y/N)	N/A	N/A	DWS Offset (in)	N/A
N/A	Shared Landing?	N/A			
N/A	Gutter Ponding?	N/A	N/A	Gutter Slope (%)	N/A
N/A	Gutter Lip Ht (in)	N/A	N/A	Gutter X Slope (%)	N/A
N/A	Painted X Walk1?	No	N/A	Painted X Walk2?	No
	X Walk 1 Direction	To NE		X Walk 2 Direction	To NW
	X Walk 1 Width (in)	N/A		X Walk 2 Width (in)	N/A
	X Walk 1 Slope (%)	4.6		X Walk 2 Slope (%)	3.0

Street 1 Name Stop Condition-Street 1 Street 2 Name Stop Condition-Street 2 WHITEHALL DR None **BROMWICH RD** StopSign
