Access Compliance Report

Public Rights-of-Way

(Curb Ramps)

Intersection ID: 28847	Main Street: BERWICK_RD	Cross Street: FAIRCHASE_AV	Location: SE
ADA ID: 86248D4DE562	Ramp Type: BlendTrans1	Initial Pass/Fail: Fail	Overall Compliance: No
		Severity Score: 10

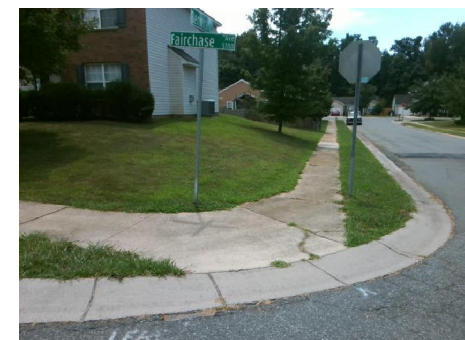
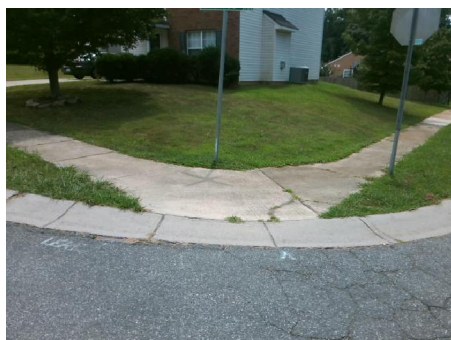
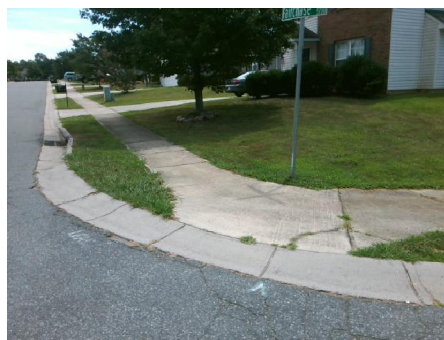
Not Found, R304.5.1, R304.5.3

Compliance	Description	Data	Compliance	Description	Data
N/A	Ramp Length (in)	48.0	Yes	BlendTrans Slope (%)	1.2
No	Ramp Width (in)	45.0	No	BlendTrans XSlope (%)	4.9
N/A	Flare Type LT	N/A	N/A	Flare Type RT	N/A
N/A	Flare Slope LT (%)	N/A	N/A	Flare Slope RT (%)	N/A
N/A	Flare Traversable LT?	N/A	N/A	Flare Traversable RT?	N/A
N/A	Landing Length (in)	N/A	N/A	DWS Provided?	N/A
N/A	Landing Width (in)	N/A	N/A	DWS Contrast?	N/A
N/A	Landing Slope (%)	N/A	N/A	DWS Length (in)	N/A
N/A	Landing X Slope (%)	N/A	N/A	DWS Full Width?	N/A
N/A	Landing Curb? (Y/N)	N/A	N/A	DWS Offset (in)	N/A
N/A	Shared Landing?	N/A			
N/A	Gutter Ponding?	N/A	N/A	Gutter Slope (%)	N/A
N/A	Gutter Lip Ht (in)	N/A	N/A	Gutter X Slope (%)	N/A
N/A	Painted X Walk1?	No	N/A	Painted X Walk2?	No
	X Walk 1 Direction	To N		X Walk 2 Direction	To W
	X Walk 1 Width (in)	N/A		X Walk 2 Width (in)	N/A
	X Walk 1 Slope (%)	6.4		X Walk 2 Slope (%)	0.9
	X Walk 1 X Slope (%)	3.9		X Walk 2 X Slope (%)	6.8

N/A	Ramp inside XWalk1?	N/A	N/A	Ramp inside XWalk2?	N/A
	Road Slope (%)	4.7		Clear Space?	N/A
	Road X Slope (%)	3.3	N/A	Clear Space to XWalk (in)	N/A
N/A	Any Obstructions?	N/A	N/A	Storm Grate/Utility Hazard?	N/A
	Obstruction Type			Storm Grate/Utility Type	
		N/A			N/A
			Yes	Surface Condition? (G/P)	Good
			No	Curb Slope (%)	12.5

Remove & Replace Curb Ramp With Two New Directional Ramps or Equivalent.
