Access Compliance Report

Public Rights-of-Way

(Curb Ramps)

Intersection ID: 23166	Main Street: LAUREL_POINTE_WY	Cross Street: LAUREL_VIEW_DR	Location: SE
ADA ID: 8641174EEC2A	Ramp Type: Perp	Initial Pass/Fail: Fail	Overall Compliance: No
		Severity Score: 12.5

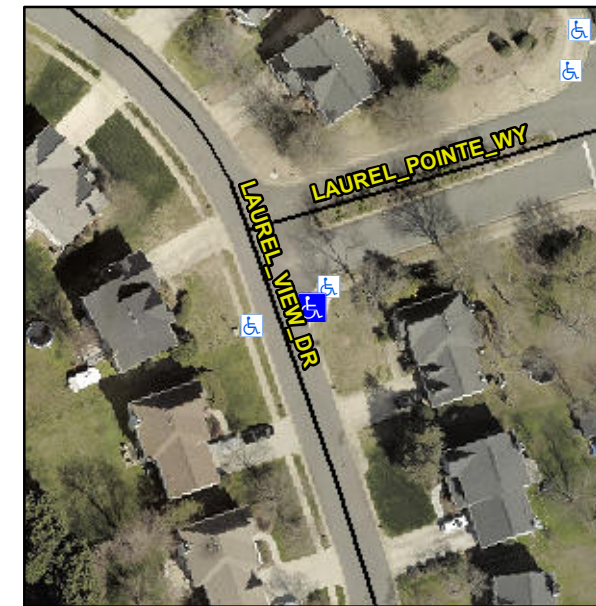
Not Found, R304.2.2

Compliance	Description	Data	Compliance	Description	Data
N/A	Ramp Length (in)	103.0	No	Ramp Slope (%)	10.2
Yes	Ramp Width (in)	48.0	Yes	Ramp XSlope (%)	0.2
N/A	Flare Type LT	N/A	N/A	Flare Type RT	N/A
N/A	Flare Slope LT (%)	N/A	N/A	Flare Slope RT (%)	N/A
N/A	Flare Traversable LT?	N/A	N/A	Flare Traversable RT?	N/A
N/A	Landing Length (in)	N/A	N/A	DWS Provided?	N/A
N/A	Landing Width (in)	N/A	N/A	DWS Contrast?	N/A
N/A	Landing Slope (%)	N/A	N/A	DWS Length (in)	N/A
N/A	Landing X Slope (%)	N/A	N/A	DWS Full Width?	N/A
N/A	Landing Curb? (Y/N)	N/A	N/A	DWS Offset (in)	N/A
N/A	Shared Landing?	N/A			
N/A	Gutter Ponding?	N/A	N/A	Gutter Slope (%)	N/A
N/A	Gutter Lip Ht (in)	N/A	N/A	Gutter X Slope (%)	N/A
N/A	Painted X Walk1?	No	N/A	Painted X Walk2?	N/A
	X Walk 1 Direction	To W		X Walk 2 Direction	N/A
N/A	X Walk 1 Width (in)	N/A	N/A	X Walk 2 Width (in)	N/A
	X Walk 1 Slope (%)	1.6		X Walk 2 Slope (%)	N/A
	X Walk 1 X Slope (%)	1.5		X Walk 2 X Slope (%)	N/A

Remove & Replace Entire Ramp.
