Access Compliance Report

Public Rights-of-Way

(Curb Ramps)

Intersection ID: 14311	Main Street: BERKELEY_AV	Cross Street: CARLTON_AV	Location: E
ADA ID: 8644DD3C1D42	Ramp Type: Directional1	Initial Pass/Fail: Fail	Overall Compliance: No
Codes/Mitigation Info/Possible Solution		Field Measurements/Component Compliance

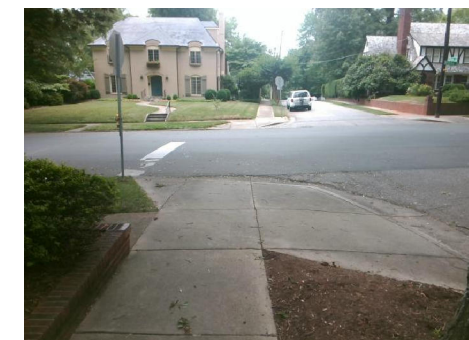
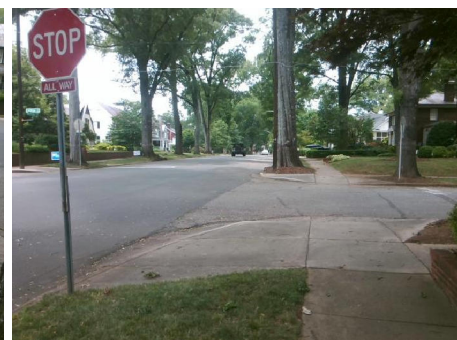
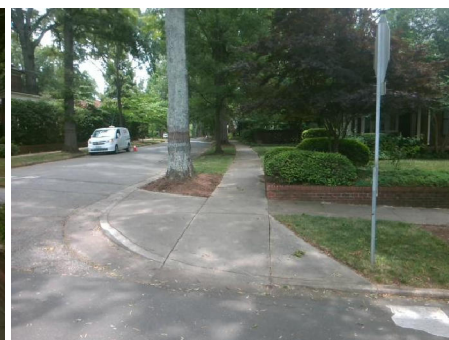
R304.2.2, R304.5.3

Compliance	Description	Data	Compliance	Description	Data
N/A	Ramp Length (in)	92.0	N/A	Grade Break?	N/A
Yes	Ramp Width (in)	59.0	N/A	Grade Break Slope (%)	0.0
No	Ramp Slope (%)	8.4	N/A	Grade Break XSlope (%)	0.0
No	Ramp XSlope (%)	2.1			
N/A	Flare Type LT	N/A	N/A	Flare Type RT	N/A
N/A	Flare Slope LT (%)	N/A	N/A	Flare Slope RT (%)	0.0
N/A	Flare Traversable LT?	N/A	N/A	Flare Traversable RT?	N/A
N/A	Landing Length (in)	0.0	N/A	DWS Provided?	N/A
N/A	Landing Width (in)	0.0	N/A	DWS Contrast?	N/A
N/A	Landing Slope (%)	0.0	N/A	DWS Length (in)	N/A
N/A	Landing X Slope (%)	0.0	N/A	DWS Full Width?	N/A
N/A	Landing Curb? (Y/N)	N/A	N/A	DWS Offset LT (in)	N/A
N/A	Shared Landing?	N/A	N/A	DWS Offset RT (in)	N/A
N/A	Gutter Ponding?	0.0	N/A	Gutter Slope (%)	N/A
N/A	Gutter Lip Ht (in)	1.0	N/A	Gutter X Slope (%)	N/A
N/A	Painted X Walk1?	No		Road Slope (%)	4.1
	X Walk 1 Direction	To SW		Road X Slope (%)	4.8
	X Walk 1 Width (in)	N/A		Clear Space?	N/A

X Walk 1 Slope (%)	4.1	N/A	Clear Space to XWalk (in)	N/A
	X Walk 1 X Slope (%)	4.8	N/A	Storm Grate/Utility Hazard?	N/A
N/A	Ramp inside XWalk1?	N/A		Storm Grate/Utility Type	
N/A	Any Obstructions?	N/A			N/A
	Obstruction Type		Yes	Surface Condition? (G/P)	Good
		N/A	N/A	Curb Slope (%)	5.8

Remove & Replace Entire Ramp.
