Access Compliance Report

Public Rights-of-Way

(Curb Ramps)

Intersection ID: 27280	Main Street: BACK_RIDGE_RD	Cross Street: ELMSTONE_DR	Location: NW
ADA ID: 864AF1010C79	Ramp Type: BlendTrans2	Initial Pass/Fail: Fail	Overall Compliance: No
Codes/Mitigation Info/Possible Solution		Field Measurements/Component Compliance	
Severity Score: 25

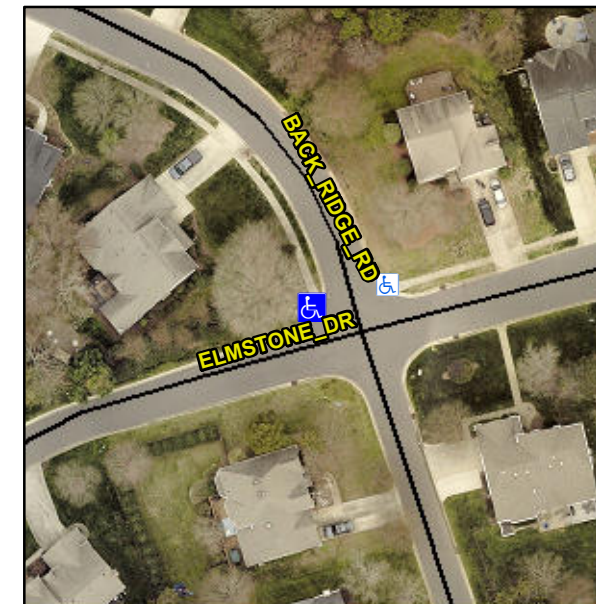
Not Found, R304.5.3

Remove & Replace Curb Ramp With Two New Directional Ramps or Equivalent.

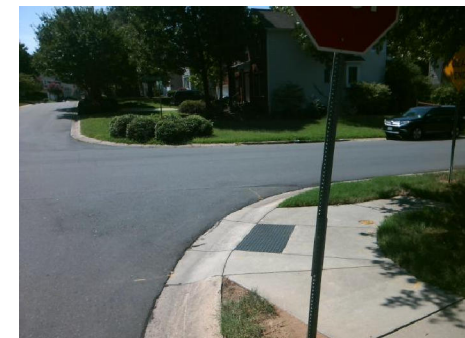
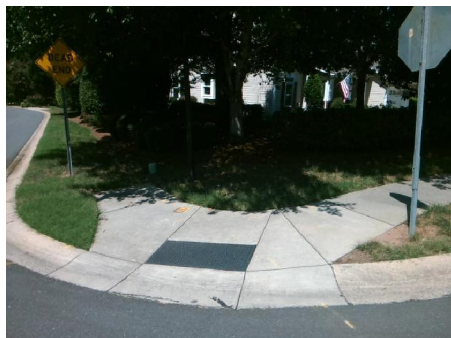
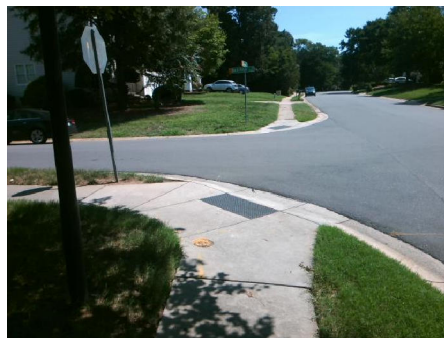
Compliance	Description	Data	Compliance	Description	Data
N/A	Ramp Length (in)	70.0	Yes	BlendTrans Slope (%)	1.8
Yes	Ramp Width (in)	48.0	No	BlendTrans XSlope (%)	9.4
N/A	Flare Type LT	N/A	N/A	Flare Type RT	N/A
N/A	Flare Slope LT (%)	N/A	N/A	Flare Slope RT (%)	N/A
N/A	Flare Traversable LT?	N/A	N/A	Flare Traversable RT?	N/A
N/A	Landing Length (in)	N/A	N/A	DWS Provided?	N/A
N/A	Landing Width (in)	N/A	N/A	DWS Contrast?	N/A
N/A	Landing Slope (%)	N/A	N/A	DWS Length (in)	N/A
N/A	Landing X Slope (%)	N/A	N/A	DWS Full Width?	N/A
N/A	Landing Curb? (Y/N)	N/A	N/A	DWS Offset (in)	N/A
N/A	Shared Landing?	N/A			
N/A	Gutter Ponding?	N/A	N/A	Gutter Slope (%)	N/A
N/A	Gutter Lip Ht (in)	N/A	N/A	Gutter X Slope (%)	N/A
N/A	Painted X Walk1?	No	N/A	Painted X Walk2?	No
	X Walk 1 Direction	To SE		X Walk 2 Direction	To NE
	X Walk 1 Width (in)	N/A		X Walk 2 Width (in)	N/A
	X Walk 1 Slope (%)	2.0		X Walk 2 Slope (%)	7.7
	X Walk 1 X Slope (%)	7.7		X Walk 2 X Slope (%)	4.3

N/A	Ramp inside XWalk1?	N/A	N/A	Ramp inside XWalk2?	N/A
	Road Slope (%)	5.2		Clear Space?	N/A
	Road X Slope (%)	7.6	N/A	Clear Space to XWalk (in)	N/A
N/A	Any Obstructions?	N/A	N/A	Storm Grate/Utility Hazard?	N/A
	Obstruction Type			Storm Grate/Utility Type	
		N/A			N/A
			Yes	Surface Condition? (G/P)	Good
			No	Curb Slope (%)	13.1
