## Access Compliance Report Public Rights-of-Way (Curb Ramps)

Intersection ID: 24479 Main Street: MEGINGTON\_DR Cross Street: SPRINGS\_FARM\_LN Location: NE

ADA ID: 865758764780 Ramp Type: PerpDiag Initial Pass/Fail: Fail Overall Compliance: No Severity Score: 8.75

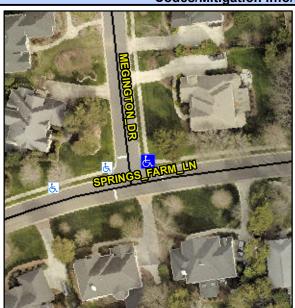
Field Measurements/Component Compliance						
	Compliance Description		Data	Comp	oliance Description	Data
	N/A	Ramp Length (in)	94.0	Yes	Ramp Slope (%)	7.0
	No	Ramp Width (in)	47.0	Yes	Ramp XSlope (%)	1.7
	N/A	Flare Type LT	N/A	N/A	Flare Type RT	N/A
	N/A	Flare Slope LT (%)	N/A	N/A	Flare Slope RT (%)	N/A
	N/A	Flare Traversable LT?	N/A	N/A	Flare Traversable RT?	N/A
	N/A	Landing Length (in)	N/A	N/A	DWS Provided?	N/A
	N/A	Landing Width (in)	N/A	N/A	DWS Contrast?	N/A
	N/A	Landing Slope (%)	N/A	N/A	DWS Length (in)	N/A
	N/A	Landing X Slope (%)	N/A	N/A	DWS Full Width?	N/A
	N/A	Landing Curb? (Y/N)	N/A	N/A	DWS Offset (in)	N/A
	N/A	Shared Landing?	N/A			
	N/A	Gutter Ponding?	N/A	N/A	Gutter Slope (%)	N/A
	N/A	Gutter Lip Ht (in)	N/A	N/A	Gutter X Slope (%)	N/A
	N/A	Painted X Walk1?	No	N/A	Painted X Walk2?	No
		X Walk 1 Direction	To W		X Walk 2 Direction	To S
	N/A	X Walk 1 Width (in)	N/A	N/A	X Walk 2 Width (in)	N/A
		X Walk 1 Slope (%)	0.4		X Walk 2 Slope (%)	2.5

X Walk 1 X Slope (%)	1.5		X Walk 2 X Slope (%)	1.8
	N/A	Ramp inside XWalk1?	N/A	N/A	Ramp inside XWalk2?	N/A
		Road Slope (%)	1.2	N/A	Clear Space?	N/A
		Road X Slope (%)	0.0	N/A	Clear Space to XWalk (in)	N/A
	N/A	Any Obstructions?	N/A	N/A	Storm Grate/Utility Hazard?	N/A
		Obstruction Type			Storm Grate/Utility Type	
			N/A			N/A
				Yes	Surface Condition? (G/P)	Good
(2

Remove & Replace Curb Ramp With
Two New Directional Ramps or
Equivalent.

R304.5.1
