Access Compliance Report

Public Rights-of-Way

(Curb Ramps)

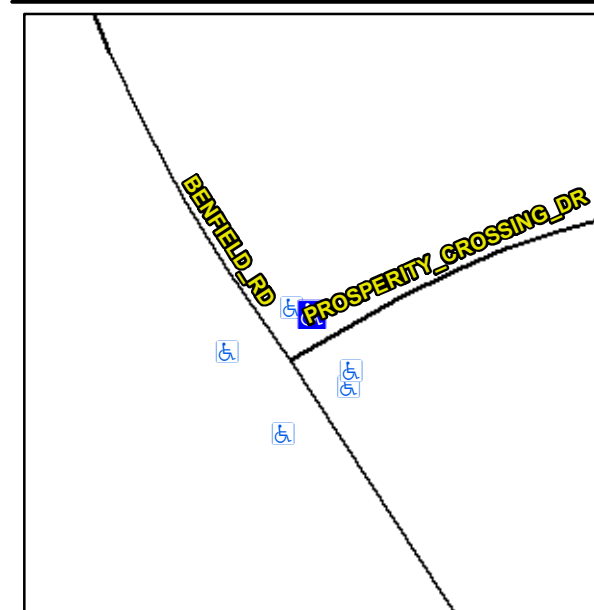
Intersection ID: 49102	Main Street: PROSPERITY_CROSSING_DR	Cross Street: BENFIELD_RD	Location: N
ADA ID: 865938CF8F92	Ramp Type: Directional1	Initial Pass/Fail: Fail	Overall Compliance: No
Severity Score: 13.75			
Codes/Mitigation Info/Possible Solution		Field Measurements/Component Compliance

R304.2.2, R304.5.3

Compliance	Description	Data	Compliance	Description	Data
N/A	Ramp Length (in)	71.0	N/A	Grade Break?	N/A
Yes	Ramp Width (in)	70.0	N/A	Grade Break Slope (%)	0.0
No	Ramp Slope (%)	9.0	N/A	Grade Break XSlope (%)	0.0
No	Ramp XSlope (%)	3.1			
N/A	Flare Type LT	N/A	N/A	Flare Type RT	N/A
N/A	Flare Slope LT (%)	N/A	N/A	Flare Slope RT (%)	0.0
N/A	Flare Traversable LT?	N/A	N/A	Flare Traversable RT?	N/A
N/A	Landing Length (in)	0.0	N/A	DWS Provided?	N/A
N/A	Landing Width (in)	0.0	N/A	DWS Contrast?	N/A
N/A	Landing Slope (%)	0.0	N/A	DWS Length (in)	N/A
N/A	Landing X Slope (%)	0.0	N/A	DWS Full Width?	N/A
N/A	Landing Curb? (Y/N)	N/A	N/A	DWS Offset LT (in)	N/A
N/A	Shared Landing?	N/A	N/A	DWS Offset RT (in)	N/A
N/A	Gutter Ponding?	0.0	N/A	Gutter Slope (%)	N/A
N/A	Gutter Lip Ht (in)	0.0	N/A	Gutter X Slope (%)	N/A
N/A	Painted X Walk1?	No		Road Slope (%)	1.5
	X Walk 1 Direction	To SE		Road X Slope (%)	5.5
	X Walk 1 Width (in)	N/A		Clear Space?	N/A

X Walk 1 Slope (%)	1.5	N/A	Clear Space to XWalk (in)	N/A
	X Walk 1 X Slope (%)	5.5	N/A	Storm Grate/Utility Hazard?	N/A
N/A	Ramp inside XWalk1?	N/A		Storm Grate/Utility Type	
N/A	Any Obstructions?	N/A			N/A
	Obstruction Type		Yes	Surface Condition? (G/P)	Good
			N/A	Curb Slope (%)	5.3

Remove & Replace Entire Ramp.
