Access Compliance Report

Public Rights-of-Way

(Curb Ramps)

| Intersection ID: 31480 | Main Street: FLAGLER_LN | Cross Street: SUNMAN_RD | Location: SE |

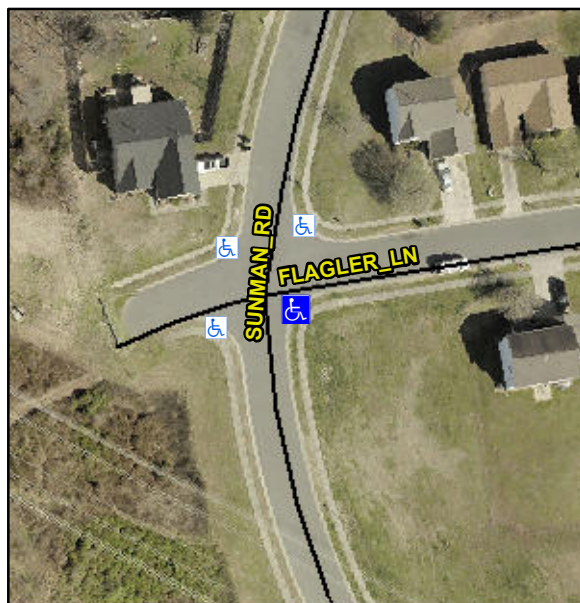
| ADA ID: 865A0538E73B | Ramp Type: PerpDiag | Initial Pass/Fail: Fail | Overall Compliance: No |
| Severity Score: 21.25 | | | |

Not Found, R304.5.1, R304.5.3

| Compliance | Description | Data | Compliance | Description | Data |
|---|---|---|---|---|---|
| N/A | Ramp Length (in) | 43.5 | Yes | Ramp Slope (%) | 7.3 |
| No | Ramp Width (in) | 39.5 | No | Ramp XSlope (%) | 5.3 |

Remove & Replace Curb Ramp With Two New Directional Ramps or Equivalent.
