# Access Compliance Report

## Public Rights-of-Way

### (Curb Ramps)

Intersection ID: 10024493	Main Street: CROWNPOINT_EXECUTIVE_DR	Cross Street: N/A	Location: NE
ADA ID: 867A6DB405A9	Ramp Type: PerpDiag	Initial Pass/Fail: Fail	Overall Compliance: No
Severity Score: 10			
Codes/Mitigation Info/Possible Solution		Field Measurements/Component Compliance

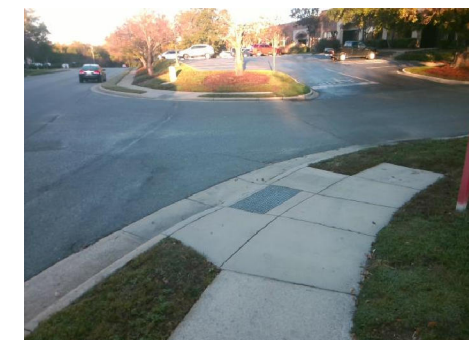
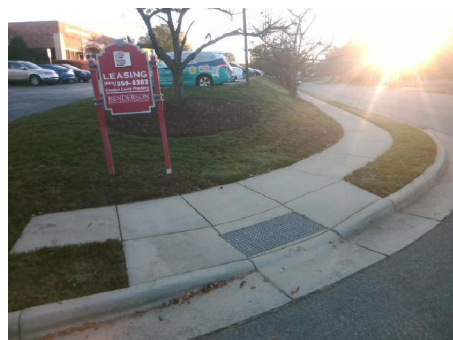
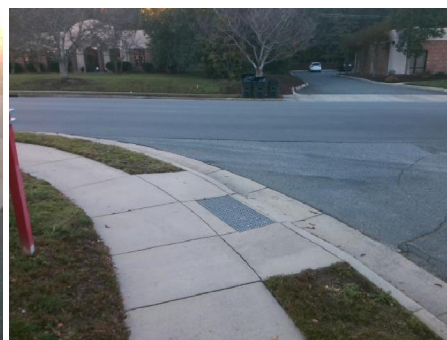
Street 1 Name **ENTRANCE**  
 Stop Condition-Street 2 **StopSign**  
 Street 2 Name **CROWNPOINT EXECUTIVE DR**  
 Stop Condition-Street 1 **None**
