# Access Compliance Report

## Public Rights-of-Way

### (Curb Ramps)

Intersection ID: 28370	Main Street: BRIDGEHAMPTON CLUB DR	Cross Street: SOUTHMOOR OAKS CT	Location: NW
ADA ID: 86837DB583AC	Ramp Type: Perp	Initial Pass/Fail: Fail	Overall Compliance: No
Severity Score: 33.75			
Codes/Mitigation Info/Possible Solution		Field Measurements/Component Compliance

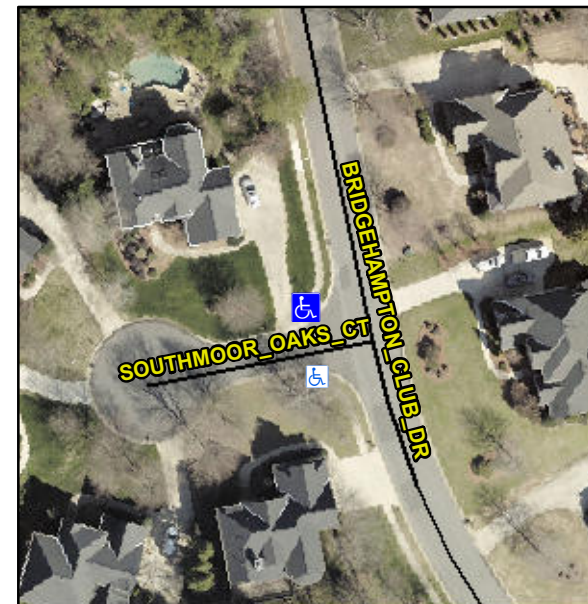
**Not Found, R304.5.1, R304.5.3**

Compliance	Description	Data	Compliance	Description	Data
N/A	Ramp Length (in)	46.0	Yes	Ramp Slope (%)	7.7
No	Ramp Width (in)	36.0	No	Ramp XSlope (%)	11.4
N/A	Flare Type LT	N/A	N/A	Flare Type RT	N/A
N/A	Flare Slope LT (%)	N/A	N/A	Flare Slope RT (%)	N/A
N/A	Flare Traversable LT?	N/A	N/A	Flare Traversable RT?	N/A
N/A	Landing Length (in)	N/A	N/A	DWS Provided?	N/A
N/A	Landing Width (in)	N/A	N/A	DWS Contrast?	N/A
N/A	Landing Slope (%)	N/A	N/A	DWS Length (in)	N/A
N/A	Landing X Slope (%)	N/A	N/A	DWS Full Width?	N/A
N/A	Landing Curb? (Y/N)	N/A	N/A	DWS Offset (in)	N/A
N/A	Shared Landing?	N/A			
N/A	Gutter Ponding?	N/A	N/A	Gutter Slope (%)	N/A
N/A	Gutter Lip Ht (in)	N/A	N/A	Gutter X Slope (%)	N/A
N/A	Painted X Walk1?	No	N/A	Painted X Walk2?	N/A
	X Walk 1 Direction	To S		X Walk 2 Direction	N/A
N/A	X Walk 1 Width (in)	N/A	N/A	X Walk 2 Width (in)	N/A
	X Walk 1 Slope (%)	5.7		X Walk 2 Slope (%)	N/A
	X Walk 1 X Slope (%)	6.0		X Walk 2 X Slope (%)	N/A

N/A	Ramp inside XWalk1?	N/A	N/A	Ramp inside XWalk2?	N/A
	Road Slope (%)	N/A	N/A	Clear Space?	N/A
	Road X Slope (%)	N/A	N/A	Clear Space to XWalk (in)	N/A
N/A	Any Obstructions?	N/A	N/A	Storm Grate/Utility Hazard?	N/A
	Obstruction Type			Storm Grate/Utility Type	
		N/A			N/A
			Yes	Surface Condition? (G/P)	Good

**Remove & Replace Entire Ramp.**

Total Cost: \$ 1850.00
