## Access Compliance Report Public Rights-of-Way (Curb Ramps)

Intersection ID: 31853	ction ID: 31853 Main Street: TIBBLE_CREEK_WY			Cross Street: WATERLEAF_LN				Location:	SE
ADA ID: 869FA142DABA	A Ramp Type: PerpDiag			nitial Pass/Fail: Fail Overall Compliance: N				o Severity Score:	12.5
Codes/Mitigation Info/Possible Solution				Field Measurements/Component Compliance					
and the second	The	Possible Solutions:		Compliance Description			Data Compliance Description		
Contraction of the		Remove & Replace Curb Ramp Wit Two New Directional Ramps or Equivalent.	Vith	N/A	Ramp Length (in)	48.0	No	Ramp Slope (%)	8.7
				Yes	Ramp Width (in)	48.0	Yes	Ramp XSlope (%)	1.9
				N/A	Flare Type LT	N/A	N/A	Flare Type RT	N/A
a la alta				N/A	Flare Slope LT (%)	N/A	N/A	Flare Slope RT (%)	N/A
TIER	A CAR			N/A	Flare Traversable LT?	N/A	N/A	Flare Traversable RT?	N/A
CERDEN CORES	a state			N/A	Landing Length (in)	N/A	N/A	DWS Provided?	N/A
1 Jacob T		Surveyor Notes:		N/A	Landing Width (in)	N/A	N/A	DWS Contrast?	N/A

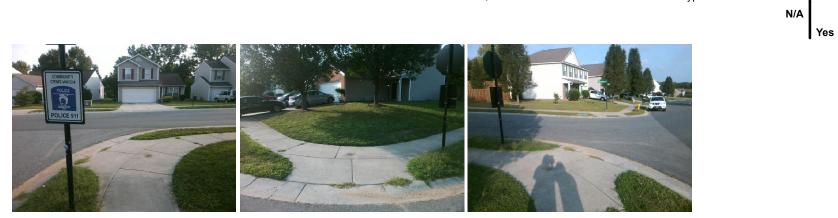
N/A		N/A	Landing Slope (%)	N/A	N/A	DWS Length (in)	N/A
The BIT				N/A	Landing X Slope (%)	N/A	N/A	DWS Full Width?	N/A
A Star H				N/A	Landing Curb? (Y/N)	N/A	N/A	DWS Offset (in)	N/A
				N/A	Shared Landing?	N/A			
		PROW/ADA:		N/A	Gutter Ponding?	N/A	N/A	Gutter Slope (%)	N/A
		R304.2.2		N/A	Gutter Lip Ht (in)	N/A	N/A	Gutter X Slope (%)	N/A
	17 2001			N/A	Painted X Walk1?	No	N/A	Painted X Walk2?	No
bring and a set	and and the first				X Walk 1 Direction	To NE		X Walk 2 Direction	To NW
				N/A	X Walk 1 Width (in)	N/A	N/A	X Walk 2 Width (in)	N/A
Street 1 Name	TIBBLE CREEK WY				X Walk 1 Slope (%)	2.2		X Walk 2 Slope (%)	2.5
Stop Condition-Street 2	None				X Walk 1 X Slope (%)	0.9		X Walk 2 X Slope (%)	0.9
Street 2 Name	WATERLEAF LN			N/A	Ramp inside XWalk1?	N/A	N/A	Ramp inside XWalk2?	N/A
Stop Condition-Street 1	StopSign				Road Slope (%)	1.4	N/A	Clear Space?	N/A
					Road X Slope (%)	2.0	N/A	Clear Space to XWalk (in)	N/A

N/A	Any Obstructions?	N/A	N/A	Storm Grate/Utility Hazard?	N/A
		Total Cost: \$ 32	200.00		Obstruction Type			Storm Grate/Utility Type	
						N/A			N/A
