# Access Compliance Report

## Public Rights-of-Way

| Intersection ID: 44822 | Main Street: GOLDEN_RIDGE_LN | Cross Street: HIRAM_ST | Location: NW |
| ADA ID: 86AD23A2073F | Ramp Type: Perp | Initial Pass/Fail: Pass | Overall Compliance: No |

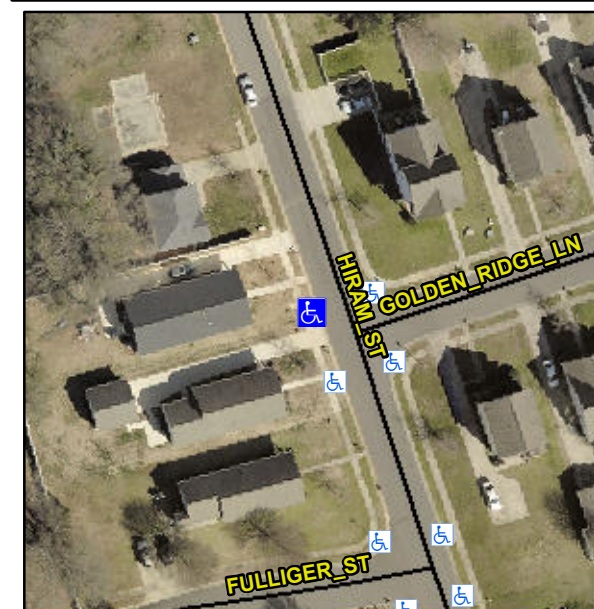
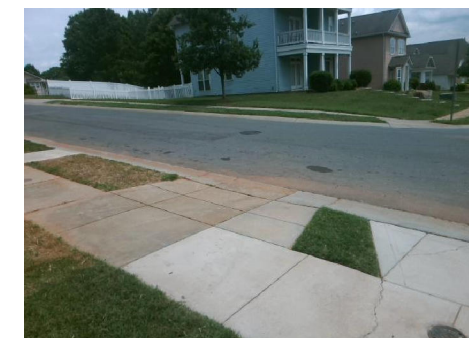
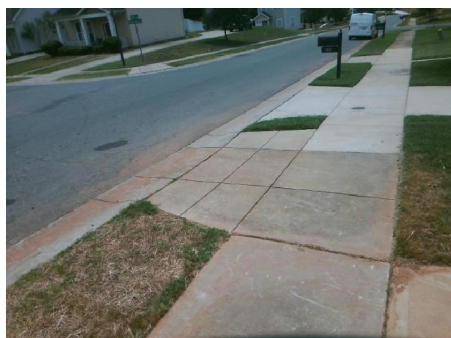
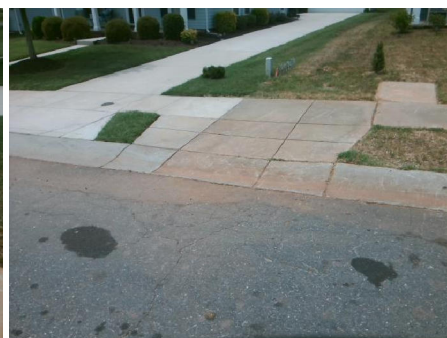
| Severity Score: 15.25 | | | |

**Not Found, R304.2.1, R304.2.2-Perp,  
R304.3.2-Para, R305, R304.5.4,  
R304.5.3**

| Compliance | Description | Data | Compliance | Description | Data |
|---|---|---|---|---|---|
| No | Landing Length (in) | 47.5 | No | DWS Provided? | No |
| No | Landing Slope (%) | 3.9 | N/A | DWS Length (in) | N/A |
| Yes | Gutter Ponding? | No | No | Gutter Slope (%) | 6.2 |
| Yes | Gutter Lip Ht (in) | 0.0 | No | Gutter X Slope (%) | 5.2 |

**Remove & Replace Entire Ramp.  
Remove & Replace Gutter.**

Total Cost: \$ 2600.00
