## Access Compliance Report Public Rights-of-Way (Curb Ramps)

Intersection ID: 26345 Main Street: BEAUCATCHER\_LN Cross Street: RHETT\_BUTLER\_PL Location: NW
ADA ID: 86B03C9F0EC0 Ramp Type: BlendTrans2 Initial Pass/Fail: Fail Overall Compliance: No Severity Score: 1.25

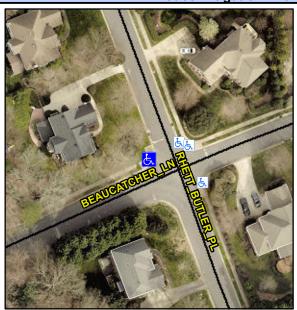
Not Found, R304.5.3

Compliance Description		Data	Comp	oliance Description	Data
N/A	Ramp Length (in)	95.0	Yes	BlendTrans Slope (%)	2.5
Yes	Ramp Width (in)	62.0	No	BlendTrans XSlope (%)	2.1
N/A	Flare Type LT	N/A	N/A	Flare Type RT	N/A
N/A	Flare Slope LT (%)	N/A	N/A	Flare Slope RT (%)	N/A
N/A	Flare Traversable LT?	N/A	N/A	Flare Traversable RT?	N/A
N/A	Landing Length (in)	N/A	N/A	DWS Provided?	N/A
N/A	Landing Width (in)	N/A	N/A	DWS Contrast?	N/A
N/A	Landing Slope (%)	N/A	N/A	DWS Length (in)	N/A
N/A	Landing X Slope (%)	N/A	N/A	DWS Full Width?	N/A
N/A	Landing Curb? (Y/N)	N/A	N/A	DWS Offset (in)	N/A
N/A	Shared Landing?	N/A			
N/A	Gutter Ponding?	N/A	N/A	Gutter Slope (%)	N/A
N/A	Gutter Lip Ht (in)	N/A	N/A	Gutter X Slope (%)	N/A
N/A	Painted X Walk1?	No	N/A	Painted X Walk2?	No
	X Walk 1 Direction	To SE		X Walk 2 Direction	To NE
	X Walk 1 Width (in)	N/A		X Walk 2 Width (in)	N/A
	X Walk 1 Slope (%)	4.1		X Walk 2 Slope (%)	3.1
	X Walk 1 X Slope (%)	4.9		X Walk 2 X Slope (%)	1.0

N/A	Ramp inside XWalk1?	N/A	N/A	Ramp inside XWalk2?	N/A
	Road Slope (%)	0.2		Clear Space?	N/A
	Road X Slope (%)	3.3	N/A	Clear Space to XWalk (in)	N/A
N/A	Any Obstructions?	N/A	N/A	Storm Grate/Utility Hazard?	N/A
	Obstruction Type		Į.	Storm Grate/Utility Type	
		N/A	l		N/A
			Yes	Surface Condition? (G/P)	Good
MA MIL	1/2		No	Curb Slope (%)	15.3

Remove & Replace Curb Ramp With Two New Directional Ramps or Equivalent.
