Access Compliance Report Public Rights-of-Way (Curb Ramps)

Intersection ID: 5094 Main Street: CLARENCEFIELD DR **Cross Street: SOUTHMINSTER LN** Location: W ADA ID: 86E527BBA675 Ramp Type: BlendTrans2 Initial Pass/Fail: Pass **Overall Compliance: No Severity Score:** 5.25

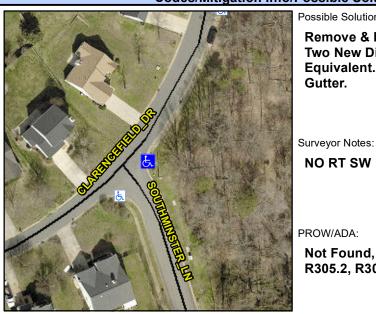
Not Found, R304.5.3, R304.2.3, R305.2, R304.5.4

Compliance Description Data		Compliance Description		Data	
N/A	Ramp Length (in)	49.0	Yes	BlendTrans Slope (%)	2.1
Yes	Ramp Width (in)	48.0	No	BlendTrans XSlope (%)	3.3
N/A	Flare Type LT	Sloped	N/A	Flare Type RT	Sloped
No	Flare Slope LT (%)	N/A	N/A	Flare Slope RT (%)	N/A
N/A	Flare Traversable LT?	Yes	N/A	Flare Traversable RT?	No
N/A	Landing Length (in)	N/A	Yes	DWS Provided?	Yes
N/A	Landing Width (in)	N/A	Yes	DWS Contrast?	Yes
N/A	Landing Slope (%)	N/A	Yes	DWS Length (in)	24.5
N/A	Landing X Slope (%)	N/A	Yes	DWS Full Width?	Yes
N/A	Landing Curb? (Y/N)	No	No	DWS Offset (in)	7.0
N/A	Shared Landing?	No			
Yes	Gutter Ponding?	No	No	Gutter Slope (%)	9.1
Yes	Gutter Lip Ht (in)	0.0	No	Gutter X Slope (%)	4.2
N/A	Painted X Walk1?	No	N/A	Painted X Walk2?	N/A
	X Walk 1 Direction	To SE		X Walk 2 Direction	N/A
	X Walk 1 Width (in)	N/A		X Walk 2 Width (in)	N/A
	X Walk 1 Slope (%)	4.6		X Walk 2 Slope (%)	N/A
	X Walk 1 X Slope (%)	5.5		X Walk 2 X Slope (%)	N/A

N/A	Ramp inside XWalk1?	N/A	N/A	Ramp inside XWalk2?	N/A
	Road Slope (%)	5.5		Clear Space?	Yes
	Road X Slope (%)	4.6	N/A	Clear Space to XWalk (in)	N/A
Yes	Any Obstructions?	No	Yes	Storm Grate/Utility Hazard?	No
	Obstruction Type		l	Storm Grate/Utility Type	
		N/A	l		N/A
			Yes	Surface Condition? (G/P)	Good

SOUTHMINSTER LN Street 1 Name Stop Condition-Street 1 StopSign Street 2 Name N/A Stop Condition-Street 2 N/A Possible Solutions: Remove & Replace Curb Ramp With Two New Directional Ramps or Equivalent. Remove & Replace Gutter.

Total Cost: 3950.00
