Access Compliance Report Public Rights-of-Way (Curb Ramps)

Intersection ID: 13861 Main Street: GANYMEDE_PL Cross Street: HOLLIROSE_DR Location: NW **ADA ID: 86F8AE74E58E** Ramp Type: Directional1 Initial Pass/Fail: Fail **Overall Compliance: No** Severity Score: 33.75

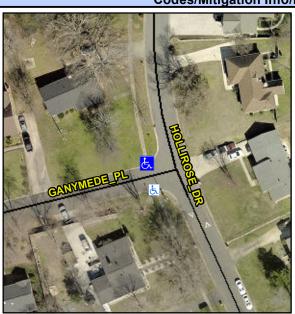
Field Measurements/Component Compliance						
Compliance Description		Data	Compliance		Description	Data
N/A	Ramp Length (in)	57.0	N/A	Grad	e Break?	N/A
No	Ramp Width (in)	46.5	N/A	Grad	e Break Slope (%)	0.0
No	Ramp Slope (%)	14.2	N/A	Grad	e Break XSlope (%)	0.0
Yes	Ramp XSlope (%)	1.9				
N/A	Flare Type LT	N/A	N/A	Flare	Type RT	N/A
N/A	Flare Slope LT (%)	N/A	N/A	Flare	Slope RT (%)	0.0
N/A	Flare Traversable LT?	N/A	N/A	Flare	Traversable RT?	N/A
N/A	Landing Length (in)	0.0	N/A	DWS	Provided?	N/A
N/A	Landing Width (in)	0.0	N/A	DWS	Contrast?	N/A
N/A	Landing Slope (%)	0.0	N/A	DWS	Length (in)	N/A
N/A	Landing X Slope (%)	0.0	N/A	DWS	Full Width?	N/A
N/A	Landing Curb? (Y/N)	N/A	N/A	DWS	Offset LT (in)	N/A
N/A	Shared Landing?	N/A	N/A	DWS	Offset RT (in)	N/A
N/A	Gutter Ponding?	0.0	N/A	Gutte	er Slope (%)	N/A
N/A	Gutter Lip Ht (in)	2.0	N/A	Gutte	er X Slope (%)	N/A
N/A	Painted X Walk1?	No		Road	Slope (%)	1.
	X Walk 1 Direction	To S		Road	X Slope (%)	2.0

X Walk 1 Width (in)	N/A		Clear	Space?	N/A
	X Walk 1 Slope (%)	1.1	N/A	Clear	Space to XWalk (in)	N/A
	X Walk 1 X Slope (%)	2.0	N/A	Storn	n Grate/Utility Hazard?	N/A
N/A	Ramp inside XWalk1?	N/A		Storn	n Grate/Utility Type	
N/A	Any Obstructions?	N/A				N/A
	Obstruction Type		Yes	Surfa	ce Condition? (G/P)	Good
		N/A	N/A	Curb	Slope (%)	11.7

Possible Solutions: Remove & Replace Entire Ramp. Surveyor Notes: N/A R304.5.1, R304.2.2
