## Access Compliance Report Public Rights-of-Way (Curb Ramps)

Intersection ID: 53492 Main Street: MCGILL\_HEIGHTS\_RD Cross Street: MATTHEWS\_FARM\_LN Location: SE

ADA ID: 86FA8D93B1DF Ramp Type: Perp Initial Pass/Fail: Pass Overall Compliance: No Severity Score: 17.5

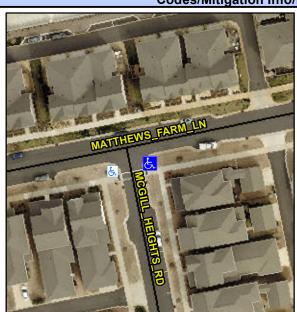
Field Measurements/Component Compliance								
Com	pliance Description	Data	Comp	liance De	scription	Data		
N/A	Ramp Length (in)	158.0	Yes	Ramp Slo	ppe (%)	5.3		
Yes	Ramp Width (in)	71.0	Yes	Ramp XS	lope (%)	1.5		
Yes	Flare Type L <b>Curbed_NoWalkSurface</b>		Yes	Flare Typ	e RT	N/A		
Yes	Flare Slope LT (%)	N/A	N/A	Flare Slo	pe RT (%)	N/A		
N/A	Flare Traversable LT?	No	N/A	Flare Tra	versable RT?	No		
Yes	Landing Length (in)	72.0	Yes	DWS Pro	vided?	Yes		
Yes	Landing Width (in)	71.0	Yes	DWS Cor	ntrast?	Yes		
Yes	Landing Slope (%)	0.6	Yes	DWS Length (in)		24.0		
Yes	Landing X Slope (%)	1.0	No	DWS Full Width?		No		
N/A	Landing Curb? (Y/N)	No	Yes	DWS Offs	set (in)	2.0		
N/A	Shared Landing?	No						
Yes	Gutter Ponding?	No	Yes	Gutter Slope (%)		2.5		
No	Gutter Lip Ht (in)	1.5	Yes	Gutter X Slope (%)		1.1		
N/A	Painted X Walk1?	No	N/A	Painted X Walk2?		N/A		
	X Walk 1 Direction	To W		X Walk 2	Direction	N/A		
N/A	X Walk 1 Width (in)	N/A	N/A	X Walk 2 Width (in)		N/A

X Walk 1 Slope (%)	2.3		X Walk 2	Slope (%)	N/A		
	X Walk 1 X Slope (%)	0.1		X Walk 2	X Slope (%)	N/A		
N/A	Ramp inside XWalk1?	N/A	N/A	Ramp ins	ide XWalk2?	N/A		
	Road Slope (%)	N/A	N/A	Clear Spa	ace?	Yes		
	Road X Slope (%)	N/A	N/A	Clear Spa	ace to XWalk (in)	N/A		
Yes	Any Obstructions?	No	Yes	Storm Grate/Utility Hazard?		No		
	Obstruction Type			Storm Gr	ate/Utility Type			
		N/A				N/A		
			Yes	Surface C	Condition? (G/P)	Good

Remove & Replace Detectable
Warning System. Grind Gutter Lip.

R305.1.4, R302.7.2
