Access Compliance Report

Public Rights-of-Way

(Curb Ramps)

Intersection ID: 10151	Main Street: E_37TH_ST	Cross Street: N_MCDOWELL_ST	Location: S
ADA ID: 87061650D3A5	Ramp Type: Perp	Initial Pass/Fail: Fail	Overall Compliance: No
		Severity Score: 12.5	
Codes/Mitigation Info/Possible Solution		Field Measurements/Component Compliance

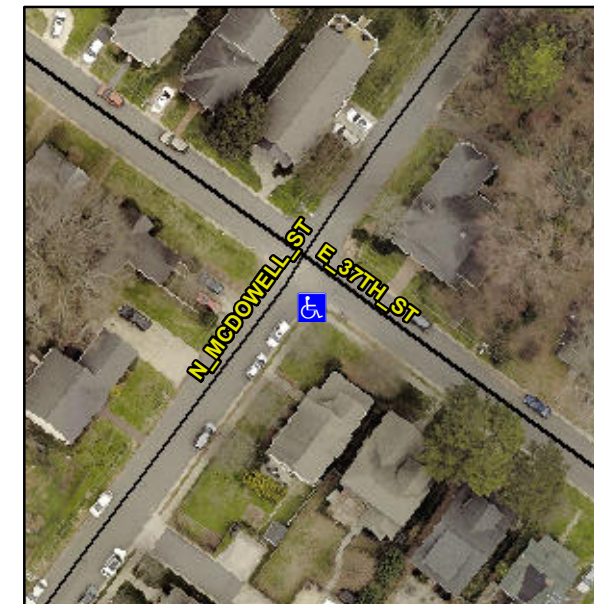
Not Found, R304.5.3

Compliance	Description	Data	Compliance	Description	Data
N/A	Ramp Length (in)	27.0	Yes	Ramp Slope (%)	8.3
Yes	Ramp Width (in)	48.0	No	Ramp XSlope (%)	6.8
N/A	Flare Type LT	N/A	N/A	Flare Type RT	N/A
N/A	Flare Slope LT (%)	N/A	N/A	Flare Slope RT (%)	N/A
N/A	Flare Traversable LT?	N/A	N/A	Flare Traversable RT?	N/A
N/A	Landing Length (in)	N/A	N/A	DWS Provided?	N/A
N/A	Landing Width (in)	N/A	N/A	DWS Contrast?	N/A
N/A	Landing Slope (%)	N/A	N/A	DWS Length (in)	N/A
N/A	Landing X Slope (%)	N/A	N/A	DWS Full Width?	N/A
N/A	Landing Curb? (Y/N)	N/A	N/A	DWS Offset (in)	N/A
N/A	Shared Landing?	N/A			
N/A	Gutter Ponding?	N/A	N/A	Gutter Slope (%)	N/A
N/A	Gutter Lip Ht (in)	N/A	N/A	Gutter X Slope (%)	N/A
N/A	Painted X Walk1?	No	N/A	Painted X Walk2?	N/A
	X Walk 1 Direction	To NW		X Walk 2 Direction	N/A
N/A	X Walk 1 Width (in)	N/A	N/A	X Walk 2 Width (in)	N/A
	X Walk 1 Slope (%)	0.1		X Walk 2 Slope (%)	N/A
	X Walk 1 X Slope (%)	5.8		X Walk 2 X Slope (%)	N/A

Possible Solutions:

Remove & Replace Entire Ramp.

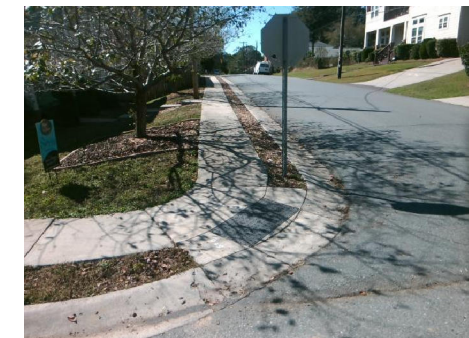
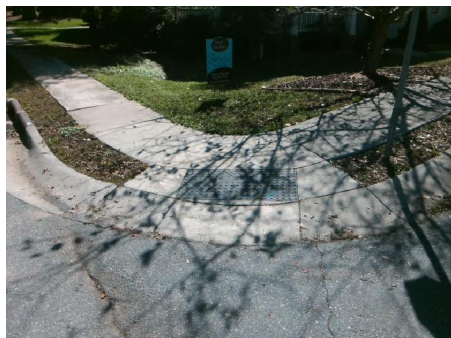
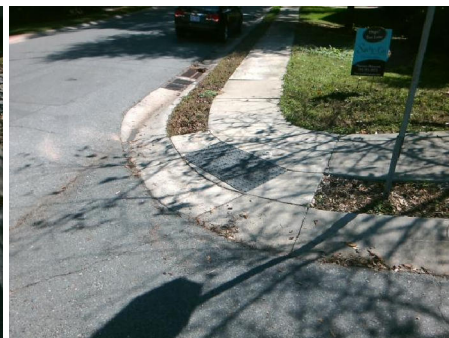
N/A	Ramp inside XWalk1?	N/A	N/A	Ramp inside XWalk2?	N/A
	Road Slope (%)	5.8	N/A	Clear Space?	N/A
	Road X Slope (%)	0.1	N/A	Clear Space to XWalk (in)	N/A
N/A	Any Obstructions?	N/A	N/A	Storm Grate/Utility Hazard?	N/A
	Obstruction Type			Storm Grate/Utility Type	
		N/A			N/A
			Yes	Surface Condition? (G/P)	Good
