# Access Compliance Report

## Public Rights-of-Way

### (Curb Ramps)

Intersection ID: 7758	Main Street: EAGLE_PEAK_DR	Cross Street: GLENMOOR_DR	Location: W
ADA ID: 8713DC0552B0	Ramp Type: Perp	Initial Pass/Fail: Fail	Overall Compliance: No
		Severity Score: 22.5

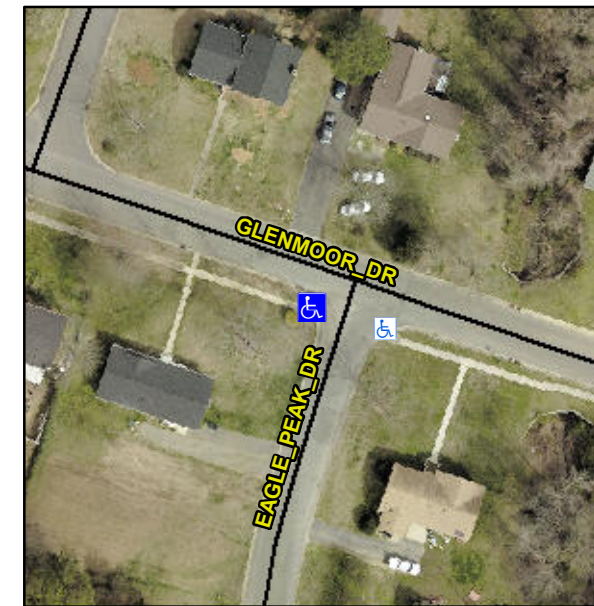
**Not Found, R304.5.1, R304.2.2, R304.5.3**

Compliance	Description	Data	Compliance	Description	Data
N/A	Ramp Length (in)	40.0	No	Ramp Slope (%)	9.2
No	Ramp Width (in)	44.5	No	Ramp XSlope (%)	4.3
N/A	Flare Type LT	N/A	N/A	Flare Type RT	N/A
N/A	Flare Slope LT (%)	N/A	N/A	Flare Slope RT (%)	N/A
N/A	Flare Traversable LT?	N/A	N/A	Flare Traversable RT?	N/A
N/A	Landing Length (in)	N/A	N/A	DWS Provided?	N/A
N/A	Landing Width (in)	N/A	N/A	DWS Contrast?	N/A
N/A	Landing Slope (%)	N/A	N/A	DWS Length (in)	N/A
N/A	Landing X Slope (%)	N/A	N/A	DWS Full Width?	N/A
N/A	Landing Curb? (Y/N)	N/A	N/A	DWS Offset (in)	N/A
N/A	Shared Landing?	N/A			
N/A	Gutter Ponding?	N/A	N/A	Gutter Slope (%)	N/A
N/A	Gutter Lip Ht (in)	N/A	N/A	Gutter X Slope (%)	N/A
N/A	Painted X Walk1?	No	N/A	Painted X Walk2?	N/A
	X Walk 1 Direction	To SE		X Walk 2 Direction	N/A
N/A	X Walk 1 Width (in)	N/A	N/A	X Walk 2 Width (in)	N/A
	X Walk 1 Slope (%)	0.9		X Walk 2 Slope (%)	N/A
	X Walk 1 X Slope (%)	2.3		X Walk 2 X Slope (%)	N/A

N/A	Ramp inside XWalk1?	N/A	N/A	Ramp inside XWalk2?	N/A
	Road Slope (%)	N/A	N/A	Clear Space?	N/A
	Road X Slope (%)	N/A	N/A	Clear Space to XWalk (in)	N/A
N/A	Any Obstructions?	N/A	N/A	Storm Grate/Utility Hazard?	N/A
	Obstruction Type			Storm Grate/Utility Type	
		N/A			N/A
			Yes	Surface Condition? (G/P)	Good

**Remove & Replace Entire Ramp.**

Total Cost: \$ 1850.00
