# Access Compliance Report

## Public Rights-of-Way

### (Curb Ramps)

| Intersection ID: N/A | Main Street: E_3RD_ST | Cross Street: S_CALDWELL_ST | Location: E |

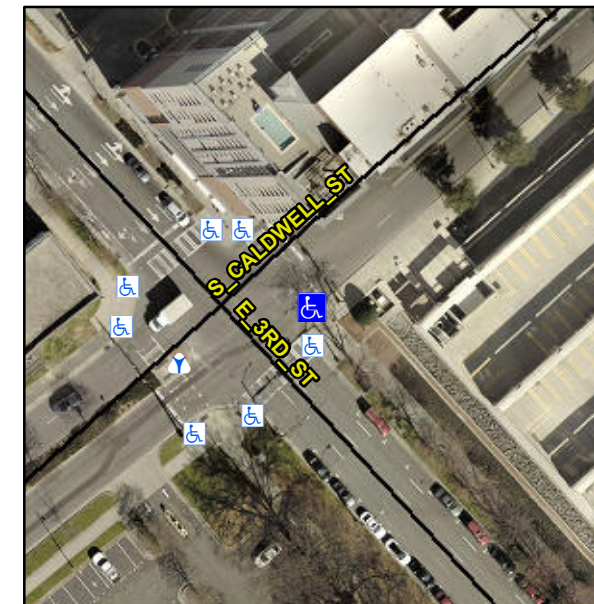
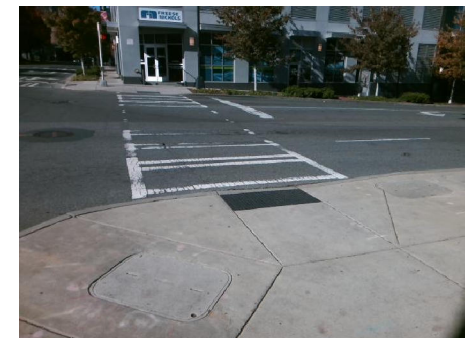
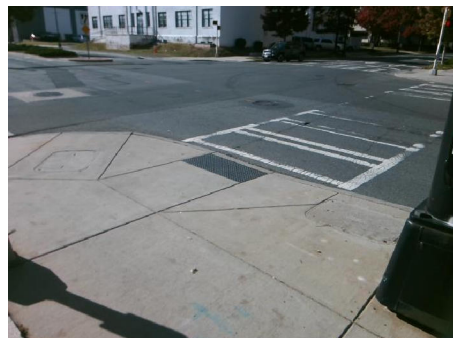
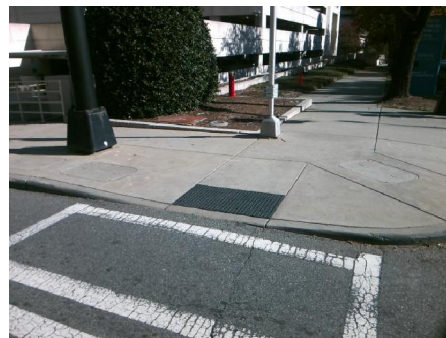
**R304.5.3**

| Compliance | Description | Data | Compliance | Description | Data |
|---|---|---|---|---|---|
| Yes | Ramp Width (in) | 48.0 | No | BlendTrans XSlope (%) | 2.2 |
| No | Landing X Slope (%) | 3.2 | Yes | DWS Full Width? | Yes |
| Yes | Gutter Lip Ht (in) | 0.0 | No | Gutter X Slope (%) | 2.5 |

**Remove & Replace Curb Ramp With Two New Directional Ramps or Equivalent. Remove & Replace Gutter.**
