Access Compliance Report

Public Rights-of-Way

(Curb Ramps)

Intersection ID: 11594	Main Street: BELFAST_DR	Cross Street: ORTON_ST	Location: NW
ADA ID: 8719A5EE721B	Ramp Type: Perp	Initial Pass/Fail: Fail	Overall Compliance: No
		Severity Score: 25

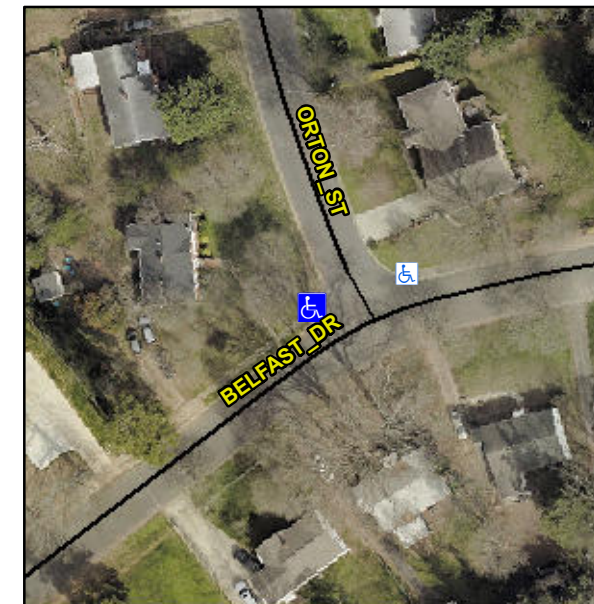
Not Found, R304.5.3

Compliance	Description	Data	Compliance	Description	Data
N/A	Ramp Length (in)	55.0	Yes	Ramp Slope (%)	6.5
Yes	Ramp Width (in)	48.0	No	Ramp XSlope (%)	10.0
N/A	Flare Type LT	N/A	N/A	Flare Type RT	N/A
N/A	Flare Slope LT (%)	N/A	N/A	Flare Slope RT (%)	N/A
N/A	Flare Traversable LT?	N/A	N/A	Flare Traversable RT?	N/A
N/A	Landing Length (in)	N/A	N/A	DWS Provided?	N/A
N/A	Landing Width (in)	N/A	N/A	DWS Contrast?	N/A
N/A	Landing Slope (%)	N/A	N/A	DWS Length (in)	N/A
N/A	Landing X Slope (%)	N/A	N/A	DWS Full Width?	N/A
N/A	Landing Curb? (Y/N)	N/A	N/A	DWS Offset (in)	N/A
N/A	Shared Landing?	N/A			
N/A	Gutter Ponding?	N/A	N/A	Gutter Slope (%)	N/A
N/A	Gutter Lip Ht (in)	N/A	N/A	Gutter X Slope (%)	N/A
N/A	Painted X Walk1?	No	N/A	Painted X Walk2?	N/A
	X Walk 1 Direction	To E		X Walk 2 Direction	N/A
N/A	X Walk 1 Width (in)	N/A	N/A	X Walk 2 Width (in)	N/A
	X Walk 1 Slope (%)	5.6		X Walk 2 Slope (%)	N/A
	X Walk 1 X Slope (%)	9.5		X Walk 2 X Slope (%)	N/A

N/A	Ramp inside XWalk1?	N/A	N/A	Ramp inside XWalk2?	N/A
	Road Slope (%)	N/A	N/A	Clear Space?	N/A
	Road X Slope (%)	N/A	N/A	Clear Space to XWalk (in)	N/A
N/A	Any Obstructions?	N/A	N/A	Storm Grate/Utility Hazard?	N/A
	Obstruction Type			Storm Grate/Utility Type	
		N/A			N/A
		Yes		Surface Condition? (G/P)	Good

Remove & Replace Entire Ramp.
