Access Compliance Report

Public Rights-of-Way

(Curb Ramps)

Intersection ID: 29145	Main Street: CRAWFORD_BROOK_LN	Cross Street: DEATON_HILL_DR	Location: NW
ADA ID: 8721D9680B7D	Ramp Type: BlendTrans1	Initial Pass/Fail: Fail	Overall Compliance: No
			Severity Score: 21.25

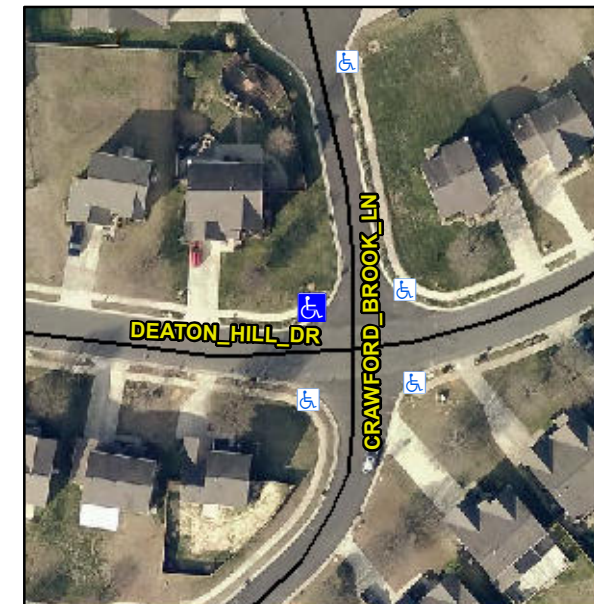
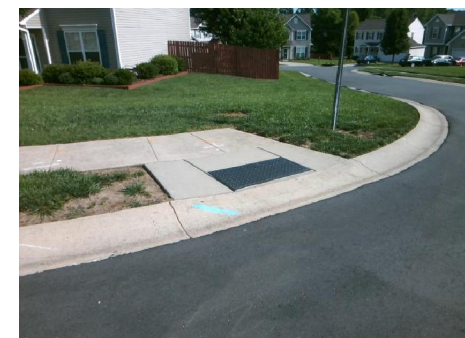
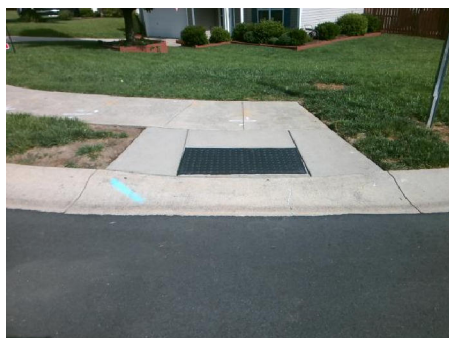
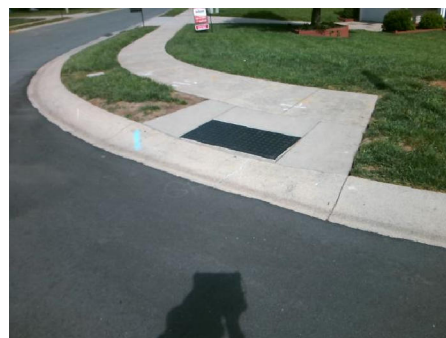
Not Found, R304.5.1, R304.5.3

Compliance	Description	Data	Compliance	Description	Data
N/A	Ramp Length (in)	30.0	Yes	BlendTrans Slope (%)	4.0
No	Ramp Width (in)	47.0	No	BlendTrans XSlope (%)	5.6
N/A	Flare Type LT	N/A	N/A	Flare Type RT	N/A
N/A	Flare Slope LT (%)	N/A	N/A	Flare Slope RT (%)	N/A
N/A	Flare Traversable LT?	N/A	N/A	Flare Traversable RT?	N/A
N/A	Landing Length (in)	N/A	N/A	DWS Provided?	N/A
N/A	Landing Width (in)	N/A	N/A	DWS Contrast?	N/A
N/A	Landing Slope (%)	N/A	N/A	DWS Length (in)	N/A
N/A	Landing X Slope (%)	N/A	N/A	DWS Full Width?	N/A
N/A	Landing Curb? (Y/N)	N/A	N/A	DWS Offset (in)	N/A
N/A	Shared Landing?	N/A			
N/A	Gutter Ponding?	N/A	N/A	Gutter Slope (%)	N/A
N/A	Gutter Lip Ht (in)	N/A	N/A	Gutter X Slope (%)	N/A
N/A	Painted X Walk1?	No	N/A	Painted X Walk2?	No
	X Walk 1 Direction	To S		X Walk 2 Direction	To E
	X Walk 1 Width (in)	N/A		X Walk 2 Width (in)	N/A
	X Walk 1 Slope (%)	4.1		X Walk 2 Slope (%)	2.2
	X Walk 1 X Slope (%)	0.7		X Walk 2 X Slope (%)	3.7

N/A	Ramp inside XWalk1?	N/A	N/A	Ramp inside XWalk2?	N/A
	Road Slope (%)	2.9		Clear Space?	N/A
	Road X Slope (%)	3.7	N/A	Clear Space to XWalk (in)	N/A
N/A	Any Obstructions?	N/A	N/A	Storm Grate/Utility Hazard?	N/A
	Obstruction Type			Storm Grate/Utility Type	
		N/A			N/A
			Yes	Surface Condition? (G/P)	Good
			No	Curb Slope (%)	5.5

Remove & Replace Curb Ramp With Two New Directional Ramps or Equivalent.
