## **Access Compliance Report Public Rights-of-Way** (Curb Ramps)

Intersection ID: 43079 Main Street: SUMTER\_AV **Cross Street: WALNUT AV** Location: ADA ID: 872FE5C24073 Ramp Type: PerpDiag Initial Pass/Fail: Fail **Overall Compliance: No** Severity Score: 33.75

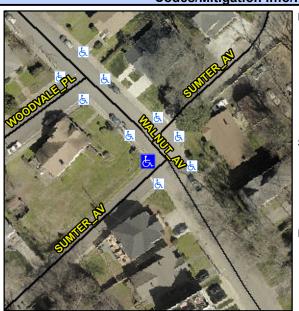
Not Found, R304.5.1, R304.5.3

Fleid Measurements/Component Compilance						
Compliance Description		Data	Compliance Description		Data	
N/A	Ramp Length (in)	56.0	Yes	Ramp Slope (%)	5.6	
No	Ramp Width (in)	38.0	No	Ramp XSlope (%)	11.4	
N/A	Flare Type LT	N/A	N/A	Flare Type RT	N/A	
N/A	Flare Slope LT (%)	N/A	N/A	Flare Slope RT (%)	N/A	
N/A	Flare Traversable LT?	N/A	N/A	Flare Traversable RT?	N/A	
N/A	Landing Length (in)	N/A	N/A	DWS Provided?	N/A	
N/A	Landing Width (in)	N/A	N/A	DWS Contrast?	N/A	
N/A	Landing Slope (%)	N/A	N/A	DWS Length (in)	N/A	
N/A	Landing X Slope (%)	N/A	N/A	DWS Full Width?	N/A	
N/A	Landing Curb? (Y/N)	N/A	N/A	DWS Offset (in)	N/A	
N/A	Shared Landing?	N/A				
N/A	Gutter Ponding?	N/A	N/A	Gutter Slope (%)	N/A	
N/A	Gutter Lip Ht (in)	N/A	N/A	Gutter X Slope (%)	N/A	
N/A	Painted X Walk1?	No	N/A	Painted X Walk2?	No	
	X Walk 1 Direction	To S		X Walk 2 Direction	ТоЕ	
N/A	X Walk 1 Width (in)	N/A	N/A	X Walk 2 Width (in)	N/A	
	X Walk 1 Slope (%)	0.3		X Walk 2 Slope (%)	5.3

X Walk 1 X Slope (%)	6.3		X Walk 2 X Slope (%)	5.3	
N/A	Ramp inside XWalk1?	N/A	N/A	Ramp inside XWalk2?	N/A	
	Road Slope (%)	10.0	N/A	Clear Space?	N/A	
	Road X Slope (%)	0.8	N/A	Clear Space to XWalk (in)	N/A	
N/A	Any Obstructions?	N/A	N/A	Storm Grate/Utility Hazard?	N/A	
	Obstruction Type			Storm Grate/Utility Type		
		N/A			N/A	
			Yes	Surface Condition? (G/P)	Good

Possible Solutions: Remove & Replace Curb Ramp With Two New Directional Ramps or Equivalent.
