Access Compliance Report

Public Rights-of-Way

(Curb Ramps)

Intersection ID: 20264	Main Street: DINGESS_RD	Cross Street: MEADHAVEN_DR	Location: W
ADA ID: 87444B11B28E	Ramp Type: PerpDiag	Initial Pass/Fail: Fail	Overall Compliance: No
Severity Score: 10			
Codes/Mitigation Info/Possible Solution		Field Measurements/Component Compliance

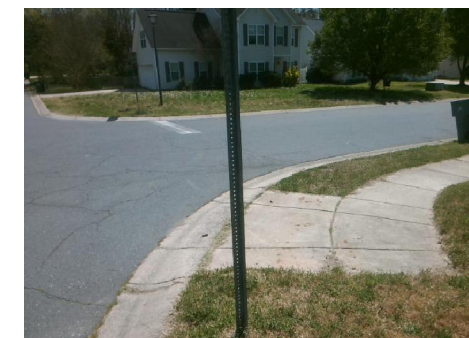
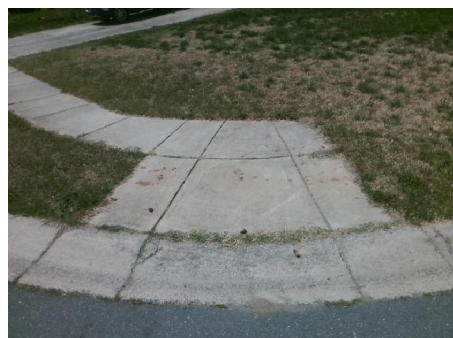
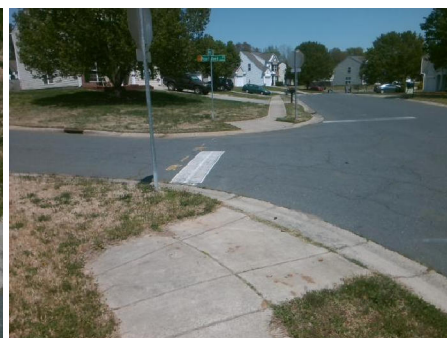
Compliance	Description	Data	Compliance	Description	Data
N/A	Ramp Length (in)	48.0	Yes	Ramp Slope (%)	7.7
No	Ramp Width (in)	38.0	No	Ramp XSlope (%)	2.1
N/A	Flare Type LT	N/A	N/A	Flare Type RT	N/A
N/A	Flare Slope LT (%)	N/A	N/A	Flare Slope RT (%)	N/A
N/A	Flare Traversable LT?	N/A	N/A	Flare Traversable RT?	N/A
N/A	Landing Length (in)	N/A	N/A	DWS Provided?	N/A
N/A	Landing Width (in)	N/A	N/A	DWS Contrast?	N/A
N/A	Landing Slope (%)	N/A	N/A	DWS Length (in)	N/A
N/A	Landing X Slope (%)	N/A	N/A	DWS Full Width?	N/A
N/A	Landing Curb? (Y/N)	N/A	N/A	DWS Offset (in)	N/A
N/A	Shared Landing?	N/A			
N/A	Gutter Ponding?	N/A	N/A	Gutter Slope (%)	N/A
N/A	Gutter Lip Ht (in)	N/A	N/A	Gutter X Slope (%)	N/A
N/A	Painted X Walk1?	No	N/A	Painted X Walk2?	No
	X Walk 1 Direction	To SE		X Walk 2 Direction	To NE
N/A	X Walk 1 Width (in)	N/A	N/A	X Walk 2 Width (in)	N/A
	X Walk 1 Slope (%)	0.5		X Walk 2 Slope (%)	5.0
	X Walk 1 X Slope (%)	5.0		X Walk 2 X Slope (%)	2.3

N/A	Ramp inside XWalk1?	N/A	N/A	Ramp inside XWalk2?	N/A
	Road Slope (%)	4.1	N/A	Clear Space?	N/A
	Road X Slope (%)	4.4	N/A	Clear Space to XWalk (in)	N/A
N/A	Any Obstructions?	N/A	N/A	Storm Grate/Utility Hazard?	N/A
	Obstruction Type			Storm Grate/Utility Type	
		N/A			N/A
			Yes	Surface Condition? (G/P)	Good

Remove & Replace Curb Ramp With Two New Directional Ramps or Equivalent.
