# Access Compliance Report

## Public Rights-of-Way

### (Curb Ramps)

Intersection ID: N/A	Main Street: GLENBURN_LN	Cross Street: KELYN_HILLS_DR	Location: NE
ADA ID: 8749EB372DE0	Ramp Type: PerpDiag	Initial Pass/Fail: Fail	Overall Compliance: No
Severity Score: 21.25			
Codes/Mitigation Info/Possible Solution		Field Measurements/Component Compliance

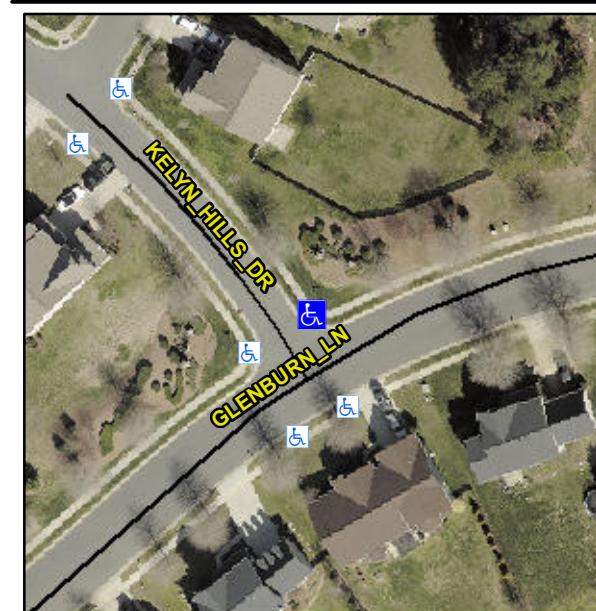
**Not Found, R304.5.1, R304.2.2**

Compliance	Description	Data	Compliance	Description	Data
N/A	Ramp Length (in)	45.0	No	Ramp Slope (%)	10.6
No	Ramp Width (in)	40.0	Yes	Ramp XSlope (%)	1.1
N/A	Flare Type LT	N/A	N/A	Flare Type RT	N/A
N/A	Flare Slope LT (%)	N/A	N/A	Flare Slope RT (%)	N/A
N/A	Flare Traversable LT?	N/A	N/A	Flare Traversable RT?	N/A
N/A	Landing Length (in)	N/A	N/A	DWS Provided?	N/A
N/A	Landing Width (in)	N/A	N/A	DWS Contrast?	N/A
N/A	Landing Slope (%)	N/A	N/A	DWS Length (in)	N/A
N/A	Landing X Slope (%)	N/A	N/A	DWS Full Width?	N/A
N/A	Landing Curb? (Y/N)	N/A	N/A	DWS Offset (in)	N/A
N/A	Shared Landing?	N/A			
N/A	Gutter Ponding?	N/A	N/A	Gutter Slope (%)	N/A
N/A	Gutter Lip Ht (in)	N/A	N/A	Gutter X Slope (%)	N/A
N/A	Painted X Walk1?	No	N/A	Painted X Walk2?	No
	X Walk 1 Direction	To SW		X Walk 2 Direction	To SE
N/A	X Walk 1 Width (in)	N/A	N/A	X Walk 2 Width (in)	N/A
	X Walk 1 Slope (%)	6.2		X Walk 2 Slope (%)	5.5
	X Walk 1 X Slope (%)	1.4		X Walk 2 X Slope (%)	7.1

N/A	Ramp inside XWalk1?	N/A	N/A	Ramp inside XWalk2?	N/A
	Road Slope (%)	1.3	N/A	Clear Space?	N/A
	Road X Slope (%)	7.0	N/A	Clear Space to XWalk (in)	N/A
N/A	Any Obstructions?	N/A	N/A	Storm Grate/Utility Hazard?	N/A
	Obstruction Type			Storm Grate/Utility Type	
		N/A			N/A
			Yes	Surface Condition? (G/P)	Good

**Remove & Replace Curb Ramp With Two New Directional Ramps or Equivalent.**

Total Cost: \$ 3200.00
