Access Compliance Report

Public Rights-of-Way

(Curb Ramps)

Intersection ID: 30544	Main Street: STONECROFT_PARK_DR	Cross Street: SUMMERHILL_RIDGE_DR	Location: SE
ADA ID: 874AEFA13069	Ramp Type: PerpDiag	Initial Pass/Fail: Fail	Overall Compliance: No
Severity Score: 21.25			
Codes/Mitigation Info/Possible Solution		Field Measurements/Component Compliance

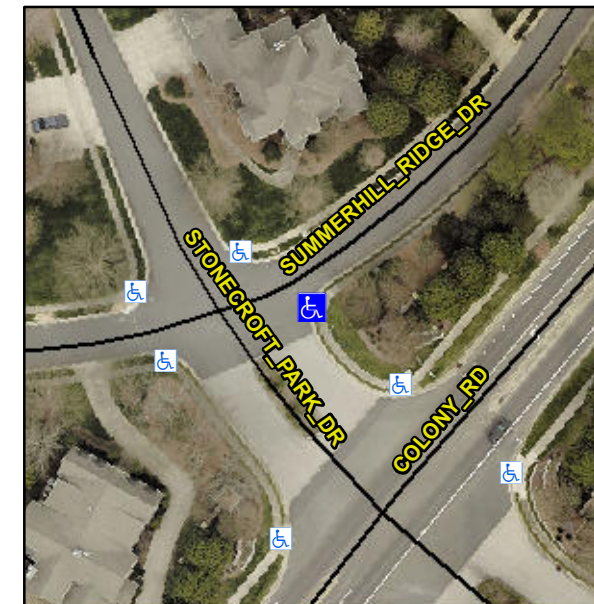
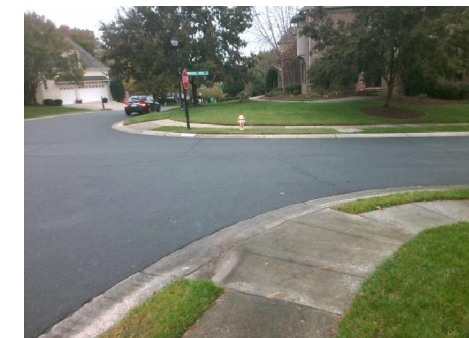
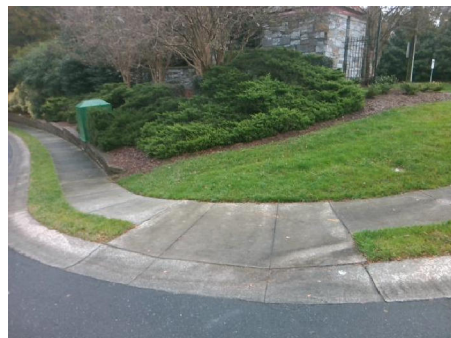
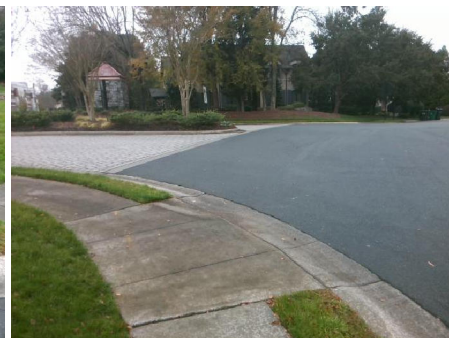
Not Found, R304.5.1, R304.5.3

Compliance	Description	Data	Compliance	Description	Data
N/A	Ramp Length (in)	72.0	Yes	Ramp Slope (%)	6.1
No	Ramp Width (in)	41.0	No	Ramp XSlope (%)	6.3
N/A	Flare Type LT	N/A	N/A	Flare Type RT	N/A
N/A	Flare Slope LT (%)	N/A	N/A	Flare Slope RT (%)	N/A
N/A	Flare Traversable LT?	N/A	N/A	Flare Traversable RT?	N/A
N/A	Landing Length (in)	N/A	N/A	DWS Provided?	N/A
N/A	Landing Width (in)	N/A	N/A	DWS Contrast?	N/A
N/A	Landing Slope (%)	N/A	N/A	DWS Length (in)	N/A
N/A	Landing X Slope (%)	N/A	N/A	DWS Full Width?	N/A
N/A	Landing Curb? (Y/N)	N/A	N/A	DWS Offset (in)	N/A
N/A	Shared Landing?	N/A			
N/A	Gutter Ponding?	N/A	N/A	Gutter Slope (%)	N/A
N/A	Gutter Lip Ht (in)	N/A	N/A	Gutter X Slope (%)	N/A
N/A	Painted X Walk1?	No	N/A	Painted X Walk2?	No
	X Walk 1 Direction	To NW		X Walk 2 Direction	To SW
N/A	X Walk 1 Width (in)	N/A	N/A	X Walk 2 Width (in)	N/A
	X Walk 1 Slope (%)	1.3		X Walk 2 Slope (%)	8.7
	X Walk 1 X Slope (%)	7.3		X Walk 2 X Slope (%)	2.4

N/A	Ramp inside XWalk1?	N/A	N/A	Ramp inside XWalk2?	N/A
	Road Slope (%)	7.5	N/A	Clear Space?	N/A
	Road X Slope (%)	5.3	N/A	Clear Space to XWalk (in)	N/A
N/A	Any Obstructions?	N/A	N/A	Storm Grate/Utility Hazard?	N/A
	Obstruction Type			Storm Grate/Utility Type	
		N/A			N/A
			Yes	Surface Condition? (G/P)	Good

Remove & Replace Curb Ramp With Two New Directional Ramps or Equivalent.
