## Access Compliance Report Public Rights-of-Way (Curb Ramps)

Intersection ID: 27269 Main Street: ELMSTONE\_DR Cross Street: WHITFIELD\_RIDGE\_DR Location: NW

ADA ID: 874B2F3080E4 Ramp Type: PerpDiag Initial Pass/Fail: Fail Overall Compliance: No Severity Score: 13.75

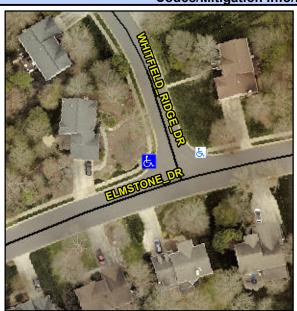
Not Found, R304.2.2, R304.5.3

Comp	Compliance Description		Compliance		Description	Data
N/A	Ramp Length (in)	48.0	No	Ramp	Slope (%)	9.4
Yes	Ramp Width (in)	48.0	No	Ramp	XSlope (%)	2.4
N/A	Flare Type LT	N/A	N/A	Flare	Type RT	N/A
N/A	Flare Slope LT (%)	N/A	N/A	Flare	Slope RT (%)	N/A
N/A	Flare Traversable LT?	N/A	N/A	Flare	Traversable RT?	N/A
N/A	Landing Length (in)	N/A	N/A	DWS	Provided?	N/A
N/A	Landing Width (in)	N/A	N/A	DWS	Contrast?	N/A
N/A	Landing Slope (%)	N/A	N/A	DWS	Length (in)	N/A
N/A	Landing X Slope (%)	N/A	N/A	DWS	Full Width?	N/A
N/A	Landing Curb? (Y/N)	N/A	N/A	DWS	Offset (in)	N/A
N/A	Shared Landing?	N/A				
N/A	Gutter Ponding?	N/A	N/A	Gutte	r Slope (%)	N/A
N/A	Gutter Lip Ht (in)	N/A	N/A	Gutte	r X Slope (%)	N/A
N/A	Painted X Walk1?	No	N/A	Paint	ed X Walk2?	No
	X Walk 1 Direction	To S		X Wa	lk 2 Direction	To E
N/A	X Walk 1 Width (in)	N/A	N/A	X Wa	lk 2 Width (in)	N/A
	X Walk 1 Slope (%)	1.2		X Wa	lk 2 Slope (%)	5.6
	X Walk 1 X Slope (%)	5.4		X Wa	lk 2 X Slope (%)	1.1

N/A	Ramp inside XWalk1?	N/A	N/A	Ram	inside XWalk2?	N/A
	Road Slope (%)	1.6	N/A	Clear	Space?	N/A
	Road X Slope (%)	3.9	N/A	Clear	Space to XWalk (in)	N/A
N/A	Any Obstructions?	N/A	N/A	Storn	n Grate/Utility Hazard?	N/A
	Obstruction Type		l	Storn	n Grate/Utility Type	
		N/A				N/A
			Yes	Surfa	ce Condition? (G/P)	Good

Remove & Replace Curb Ramp With Two New Directional Ramps or Equivalent.

Total Cost: \$ 3200.00
