Access Compliance Report

Public Rights-of-Way

(Curb Ramps)

Intersection ID: 45249	Main Street: CALDWELL_RD	Cross Street: FARMINGTON_RIDGE_PY	Location: S
ADA ID: 874E5B87464A	Ramp Type: Directional1	Initial Pass/Fail: Fail	Overall Compliance: No
		Severity Score: 12.5

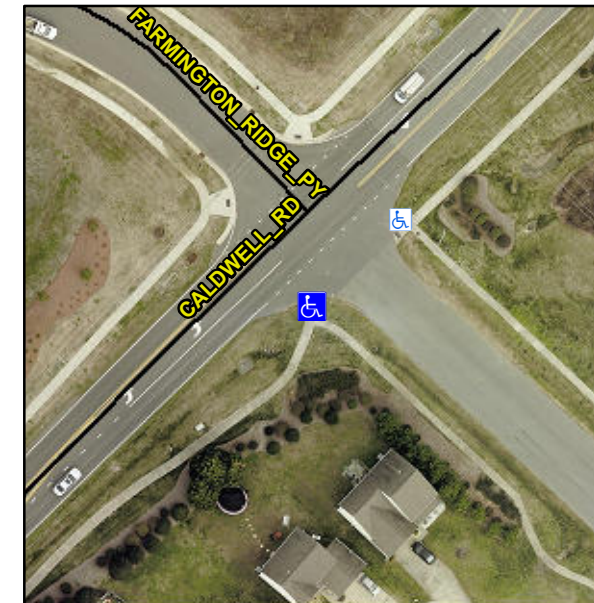
**NO CURB, NEW DEVELOPMENT NW
ACROSS CALDWELL**

R304.2.2

Compliance	Description	Data	Compliance	Description	Data
N/A	Ramp Length (in)	117.0	N/A	Grade Break?	N/A
Yes	Ramp Width (in)	58.5	N/A	Grade Break Slope (%)	0.0
No	Ramp Slope (%)	8.8	N/A	Grade Break XSlope (%)	0.0
Yes	Ramp XSlope (%)	0.5			
N/A	Flare Type LT	N/A	N/A	Flare Type RT	N/A
N/A	Flare Slope LT (%)	N/A	N/A	Flare Slope RT (%)	0.0
N/A	Flare Traversable LT?	N/A	N/A	Flare Traversable RT?	N/A
N/A	Landing Length (in)	0.0	N/A	DWS Provided?	N/A
N/A	Landing Width (in)	0.0	N/A	DWS Contrast?	N/A
N/A	Landing Slope (%)	0.0	N/A	DWS Length (in)	N/A
N/A	Landing X Slope (%)	0.0	N/A	DWS Full Width?	N/A
N/A	Landing Curb? (Y/N)	N/A	N/A	DWS Offset LT (in)	N/A
N/A	Shared Landing?	N/A	N/A	DWS Offset RT (in)	N/A
N/A	Gutter Ponding?	0.0	N/A	Gutter Slope (%)	N/A
N/A	Gutter Lip Ht (in)	3.0	N/A	Gutter X Slope (%)	N/A
N/A	Painted X Walk1?	No		Road Slope (%)	3.7
	X Walk 1 Direction	To NE		Road X Slope (%)	3.9
	X Walk 1 Width (in)	N/A		Clear Space?	N/A

X Walk 1 Slope (%)	3.7	N/A	Clear Space to XWalk (in)	N/A
	X Walk 1 X Slope (%)	3.9	N/A	Storm Grate/Utility Hazard?	N/A
N/A	Ramp inside XWalk1?	N/A		Storm Grate/Utility Type	
N/A	Any Obstructions?	N/A			N/A
	Obstruction Type		Yes	Surface Condition? (G/P)	Good
			N/A	Curb Slope (%)	N/A

Remove & Replace Entire Ramp.

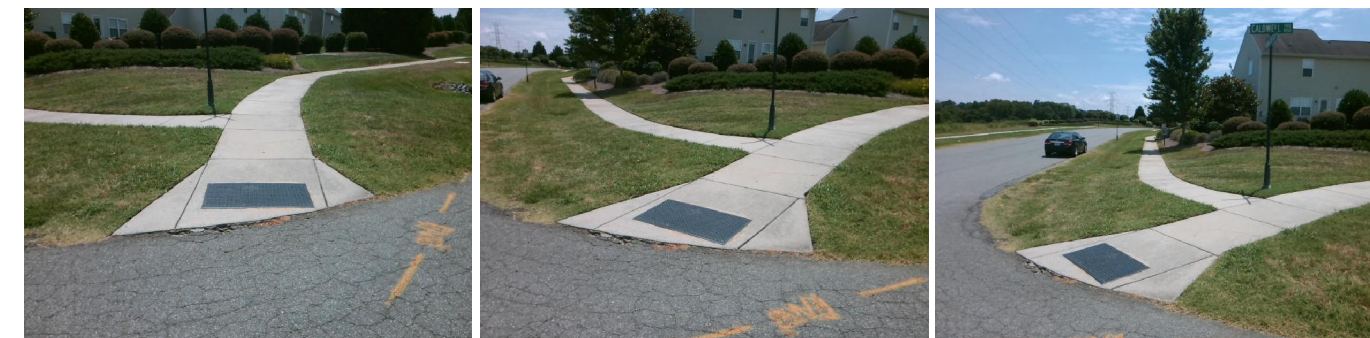
Street 1 Name	FARMINGTON RIDGE PY
Stop Condition-Street 1	StopSign
Street 2 Name	N/A
Stop Condition-Street 2	N/A
