Access Compliance Report Public Rights-of-Way (Curb Ramps)

Intersection ID: 28105 Main Street: ELLINGTON_PARK_DR Cross Street: OLIVIA_LN Location: NW

ADA ID: 874F99B804EC Ramp Type: Perp Initial Pass/Fail: Fail Overall Compliance: No Severity Score: 8.75

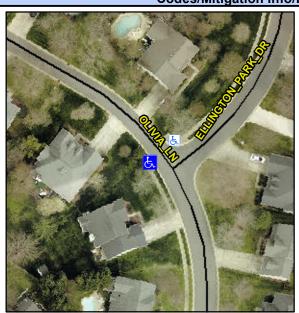
Comp	liance Description	Data	Comp	liance	Description	Data
N/A	Ramp Length (in)	53.0	Yes	Ram	Slope (%)	6.0
No	Ramp Width (in)	40.5	Yes	Ram	XSlope (%)	1.0
N/A	Flare Type LT	N/A	N/A	Flare	Type RT	N/A
N/A	Flare Slope LT (%)	N/A	N/A	Flare	Slope RT (%)	N/A
N/A	Flare Traversable LT?	N/A	N/A	Flare	Traversable RT?	N/A
N/A	Landing Length (in)	N/A	N/A	DWS	Provided?	N/A
N/A	Landing Width (in)	N/A	N/A	DWS	Contrast?	N/A
N/A	Landing Slope (%)	N/A	N/A	DWS	Length (in)	N/A
N/A	Landing X Slope (%)	N/A	N/A	DWS	Full Width?	N/A
N/A	Landing Curb? (Y/N)	N/A	N/A	DWS	Offset (in)	N/A
N/A	Shared Landing?	N/A				
N/A	Gutter Ponding?	N/A	N/A	Gutte	er Slope (%)	N/A
N/A	Gutter Lip Ht (in)	N/A	N/A	Gutte	er X Slope (%)	N/A
N/A	Painted X Walk1?	No	N/A	Paint	ed X Walk2?	N/A
	X Walk 1 Direction	To NE		X Wa	lk 2 Direction	N/A
N/A	X Walk 1 Width (in)	N/A	N/A	X Wa	lk 2 Width (in)	N/A
	X Walk 1 Slope (%)	3.3		X Wa	lk 2 Slope (%)	N/A
	X Walk 1 X Slope (%)	0.9		X Wa	lk 2 X Slope (%)	N/A

N/A	Ramp inside XWalk1?	N/A	N/A	Ram	o inside XWalk2?	N/A
	Road Slope (%)	N/A	N/A	Clear	Space?	N/A
	Road X Slope (%)	N/A	N/A	Clear	Space to XWalk (in)	N/A
N/A	Any Obstructions?	N/A	N/A	Storn	n Grate/Utility Hazard?	N/A
	Obstruction Type		l	Storn	n Grate/Utility Type	
		N/A				N/A
			Yes	Surfa	ce Condition? (G/P)	Good

Possible Solutions:	<u> </u>
Remove & Replace Entire Ramp.	
	N
	N
	N
	N
	N
Surveyor Notes:	N
N/A	N
	N
	N
	N
PROW/ADA:	N
Not Found, R304.5.1	N
,	N
	N

11/7
				N/A
				N/A
PROW/ADA:				N/A
Not Found,	R304.5.1			N/A
				N/A
				N/A
				N/A
Total Cost:		:	\$ 1850.00	N/A
