Access Compliance Report

Public Rights-of-Way

(Curb Ramps)

Intersection ID: 44115	Main Street: RUTHERGLEN_CT	Cross Street: RIDING_HILL_AV	Location: SE
ADA ID: 8754690EC8ED	Ramp Type: BlendTrans1	Initial Pass/Fail: Fail	Overall Compliance: No
			Severity Score: 21.25

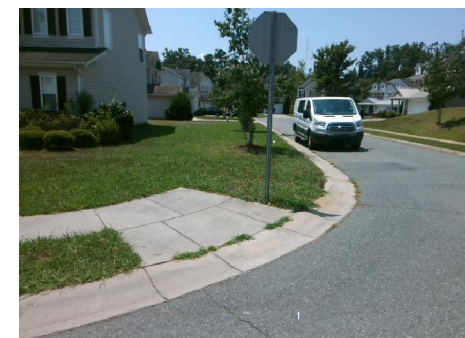
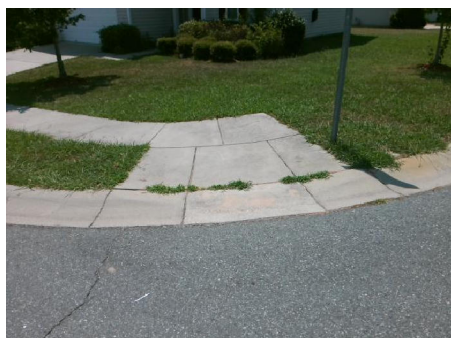
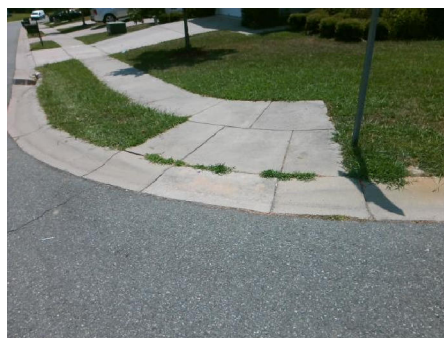
Not Found, R304.5.1, R304.5.3

Compliance	Description	Data	Compliance	Description	Data
N/A	Ramp Length (in)	47.0	Yes	BlendTrans Slope (%)	2.9
No	Ramp Width (in)	38.0	No	BlendTrans XSlope (%)	5.1
N/A	Flare Type LT	N/A	N/A	Flare Type RT	N/A
N/A	Flare Slope LT (%)	N/A	N/A	Flare Slope RT (%)	N/A
N/A	Flare Traversable LT?	N/A	N/A	Flare Traversable RT?	N/A
N/A	Landing Length (in)	N/A	N/A	DWS Provided?	N/A
N/A	Landing Width (in)	N/A	N/A	DWS Contrast?	N/A
N/A	Landing Slope (%)	N/A	N/A	DWS Length (in)	N/A
N/A	Landing X Slope (%)	N/A	N/A	DWS Full Width?	N/A
N/A	Landing Curb? (Y/N)	N/A	N/A	DWS Offset (in)	N/A
N/A	Shared Landing?	N/A			
N/A	Gutter Ponding?	N/A	N/A	Gutter Slope (%)	N/A
N/A	Gutter Lip Ht (in)	N/A	N/A	Gutter X Slope (%)	N/A
N/A	Painted X Walk1?	No	N/A	Painted X Walk2?	No
	X Walk 1 Direction	To NE		X Walk 2 Direction	To NW
	X Walk 1 Width (in)	N/A		X Walk 2 Width (in)	N/A
	X Walk 1 Slope (%)	3.6		X Walk 2 Slope (%)	6.9
	X Walk 1 X Slope (%)	6.7		X Walk 2 X Slope (%)	1.4

N/A	Ramp inside XWalk1?	N/A	N/A	Ramp inside XWalk2?	N/A
	Road Slope (%)	4.3		Clear Space?	N/A
	Road X Slope (%)	5.0	N/A	Clear Space to XWalk (in)	N/A
N/A	Any Obstructions?	N/A	N/A	Storm Grate/Utility Hazard?	N/A
	Obstruction Type			Storm Grate/Utility Type	
		N/A			N/A
			Yes	Surface Condition? (G/P)	Good
			No	Curb Slope (%)	14.9

Remove & Replace Curb Ramp With Two New Directional Ramps or Equivalent.
