# Access Compliance Report

## Public Rights-of-Way

### (Curb Ramps)

Intersection ID: 11815	Main Street: N_POPLAR_ST	Cross Street: W_7TH_ST	Location: N
ADA ID: 875E5015B919	Ramp Type: PerpDiag	Initial Pass/Fail: Fail	Overall Compliance: No
			Severity Score: 13.75

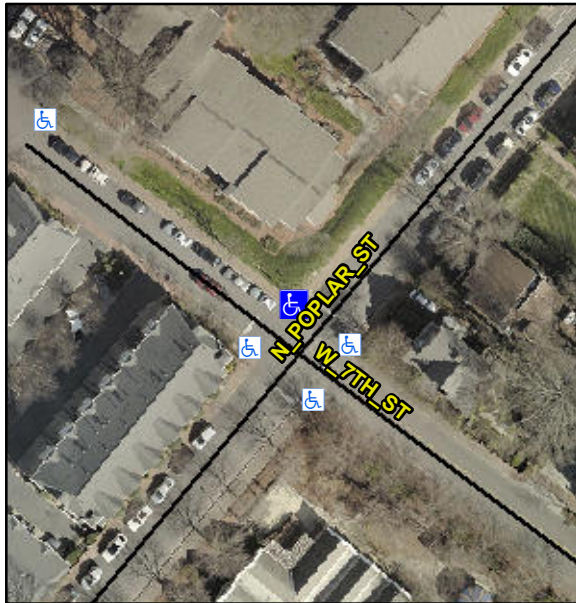
Compliance	Description	Data	Compliance	Description	Data
N/A	Ramp Length (in)	52.0	No	Ramp Slope (%)	10.2
Yes	Ramp Width (in)	50.0	No	Ramp XSlope (%)	4.1
N/A	Flare Type LT	N/A	N/A	Flare Type RT	N/A
N/A	Flare Slope LT (%)	N/A	N/A	Flare Slope RT (%)	N/A
N/A	Flare Traversable LT?	N/A	N/A	Flare Traversable RT?	N/A
N/A	Landing Length (in)	N/A	N/A	DWS Provided?	N/A
N/A	Landing Width (in)	N/A	N/A	DWS Contrast?	N/A
N/A	Landing Slope (%)	N/A	N/A	DWS Length (in)	N/A
N/A	Landing X Slope (%)	N/A	N/A	DWS Full Width?	N/A
N/A	Landing Curb? (Y/N)	N/A	N/A	DWS Offset (in)	N/A
N/A	Shared Landing?	N/A			
N/A	Gutter Ponding?	N/A	N/A	Gutter Slope (%)	N/A
N/A	Gutter Lip Ht (in)	N/A	N/A	Gutter X Slope (%)	N/A
N/A	Painted X Walk1?	No	N/A	Painted X Walk2?	No
	X Walk 1 Direction	To SW		X Walk 2 Direction	To SE
N/A	X Walk 1 Width (in)	N/A	N/A	X Walk 2 Width (in)	N/A
	X Walk 1 Slope (%)	4.1		X Walk 2 Slope (%)	6.6
	X Walk 1 X Slope (%)	6.9		X Walk 2 X Slope (%)	0.0

**Remove & Replace Curb Ramp With Two New Directional Ramps or Equivalent.**

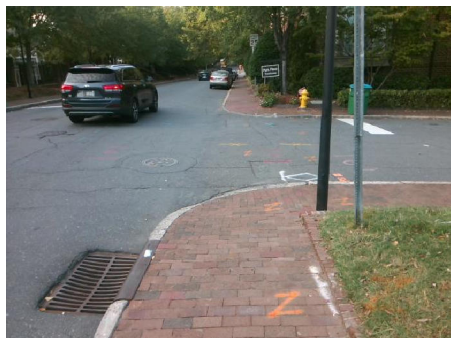
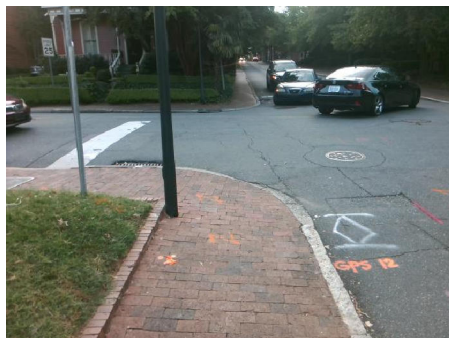
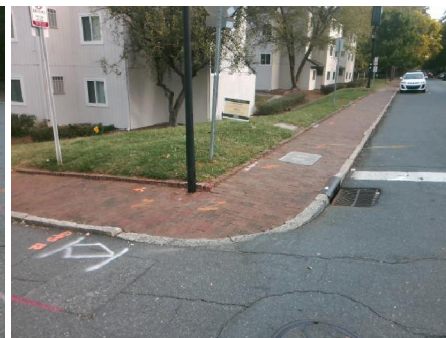
N/A	Ramp inside XWalk1?	N/A	N/A	Ramp inside XWalk2?	N/A
	Road Slope (%)	7.7	N/A	Clear Space?	N/A
	Road X Slope (%)	5.2	N/A	Clear Space to XWalk (in)	N/A
N/A	Any Obstructions?	N/A	N/A	Storm Grate/Utility Hazard?	N/A
	Obstruction Type			Storm Grate/Utility Type	
		N/A			N/A
			Yes	Surface Condition? (G/P)	Good
