Access Compliance Report

Public Rights-of-Way

(Curb Ramps)

Intersection ID: 44052	Main Street: KETTLEWELL_LN	Cross Street: LONGSTONE_LN	Location:	N
ADA ID: 876139A0D24F	Ramp Type: PerpDiag	Initial Pass/Fail: Fail	Overall Compliance: No	Severity Score: 8.75
Codes/Mitigation Info/Possible Solution		Field Measurements/Component Compliance

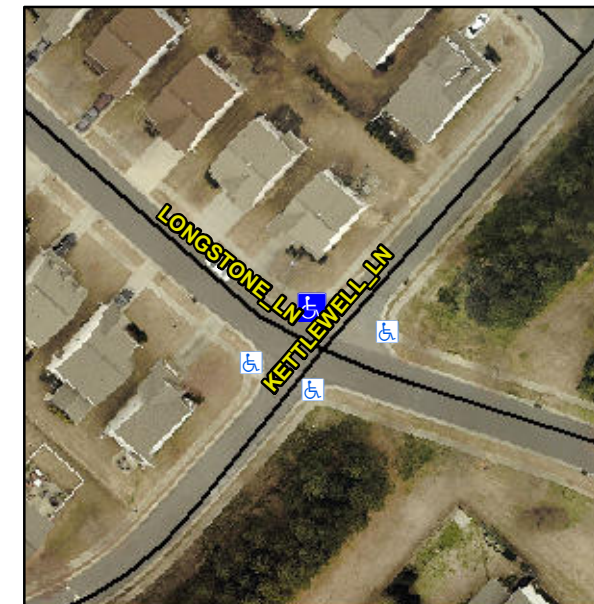
Compliance	Description	Data	Compliance	Description	Data
N/A	Ramp Length (in)	104.5	Yes	Ramp Slope (%)	7.1
No	Ramp Width (in)	40.5	Yes	Ramp XSlope (%)	0.3
N/A	Flare Type LT	N/A	N/A	Flare Type RT	N/A
N/A	Flare Slope LT (%)	N/A	N/A	Flare Slope RT (%)	N/A
N/A	Flare Traversable LT?	N/A	N/A	Flare Traversable RT?	N/A
N/A	Landing Length (in)	N/A	N/A	DWS Provided?	N/A
N/A	Landing Width (in)	N/A	N/A	DWS Contrast?	N/A
N/A	Landing Slope (%)	N/A	N/A	DWS Length (in)	N/A
N/A	Landing X Slope (%)	N/A	N/A	DWS Full Width?	N/A
N/A	Landing Curb? (Y/N)	N/A	N/A	DWS Offset (in)	N/A
N/A	Shared Landing?	N/A			
N/A	Gutter Ponding?	N/A	N/A	Gutter Slope (%)	N/A
N/A	Gutter Lip Ht (in)	N/A	N/A	Gutter X Slope (%)	N/A
N/A	Painted X Walk1?	No	N/A	Painted X Walk2?	No
	X Walk 1 Direction	To SW		X Walk 2 Direction	To SE
N/A	X Walk 1 Width (in)	N/A	N/A	X Walk 2 Width (in)	N/A
	X Walk 1 Slope (%)	1.6		X Walk 2 Slope (%)	1.8
	X Walk 1 X Slope (%)	2.2		X Walk 2 X Slope (%)	0.7

N/A	Ramp inside XWalk1?	N/A	N/A	Ramp inside XWalk2?	N/A
	Road Slope (%)	4.4	N/A	Clear Space?	N/A
	Road X Slope (%)	1.2	N/A	Clear Space to XWalk (in)	N/A
N/A	Any Obstructions?	N/A	N/A	Storm Grate/Utility Hazard?	N/A
	Obstruction Type			Storm Grate/Utility Type	
		N/A			N/A
			Yes	Surface Condition? (G/P)	Good

Possible Solutions:

Remove & Replace Curb Ramp With Two New Directional Ramps or Equivalent.

R304.5.1
