# Access Compliance Report

## Public Rights-of-Way

### (Curb Ramps)

Intersection ID: 17974	Main Street: OLD_PINEVILLE_RD	Cross Street: SPRINGBROOK_RD	Location: SW
ADA ID: 877840DBAEEC	Ramp Type: PerpDiag	Initial Pass/Fail: Fail	Overall Compliance: No
Severity Score: 10			
Codes/Mitigation Info/Possible Solution		Field Measurements/Component Compliance

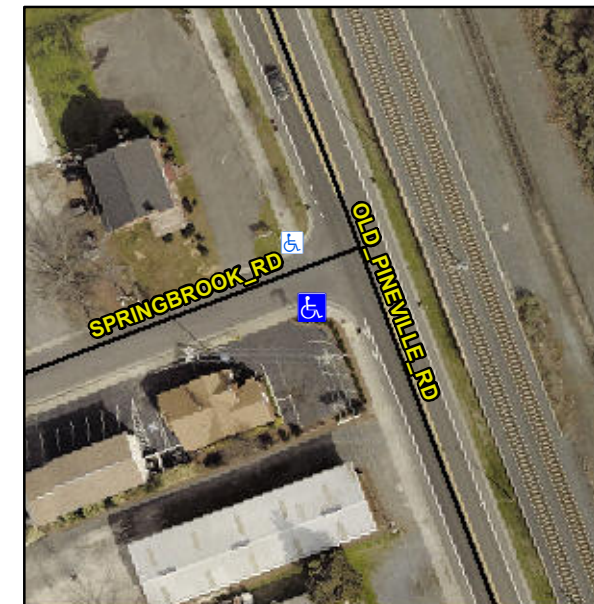
**Not Found, R304.5.1, R304.5.3**

Compliance	Description	Data	Compliance	Description	Data
N/A	Ramp Length (in)	72.0	Yes	Ramp Slope (%)	7.7
No	Ramp Width (in)	46.0	No	Ramp XSlope (%)	2.5
N/A	Flare Type LT	N/A	N/A	Flare Type RT	N/A
N/A	Flare Slope LT (%)	N/A	N/A	Flare Slope RT (%)	N/A
N/A	Flare Traversable LT?	N/A	N/A	Flare Traversable RT?	N/A
N/A	Landing Length (in)	N/A	N/A	DWS Provided?	N/A
N/A	Landing Width (in)	N/A	N/A	DWS Contrast?	N/A
N/A	Landing Slope (%)	N/A	N/A	DWS Length (in)	N/A
N/A	Landing X Slope (%)	N/A	N/A	DWS Full Width?	N/A
N/A	Landing Curb? (Y/N)	N/A	N/A	DWS Offset (in)	N/A
N/A	Shared Landing?	N/A			
N/A	Gutter Ponding?	N/A	N/A	Gutter Slope (%)	N/A
N/A	Gutter Lip Ht (in)	N/A	N/A	Gutter X Slope (%)	N/A
N/A	Painted X Walk1?	No	N/A	Painted X Walk2?	No
	X Walk 1 Direction	To E		X Walk 2 Direction	To N
N/A	X Walk 1 Width (in)	N/A	N/A	X Walk 2 Width (in)	N/A
	X Walk 1 Slope (%)	1.6		X Walk 2 Slope (%)	0.0
	X Walk 1 X Slope (%)	1.5		X Walk 2 X Slope (%)	2.5

N/A	Ramp inside XWalk1?	N/A	N/A	Ramp inside XWalk2?	N/A
	Road Slope (%)	2.1	N/A	Clear Space?	N/A
	Road X Slope (%)	0.4	N/A	Clear Space to XWalk (in)	N/A
N/A	Any Obstructions?	N/A	N/A	Storm Grate/Utility Hazard?	N/A
	Obstruction Type			Storm Grate/Utility Type	
		N/A			N/A
		Yes		Surface Condition? (G/P)	Good

**Remove & Replace Curb Ramp With Two New Directional Ramps or Equivalent.**
