Access Compliance Report

Public Rights-of-Way

(Curb Ramps)

Intersection ID: 29738	Main Street: KING_ARTHUR_DR	Cross Street: MERLIN_MEADOWS_CT	Location: N
ADA ID: 877909631C94	Ramp Type: PerpDiag	Initial Pass/Fail: Fail	Overall Compliance: No
Codes/Mitigation Info/Possible Solution		Field Measurements/Component Compliance

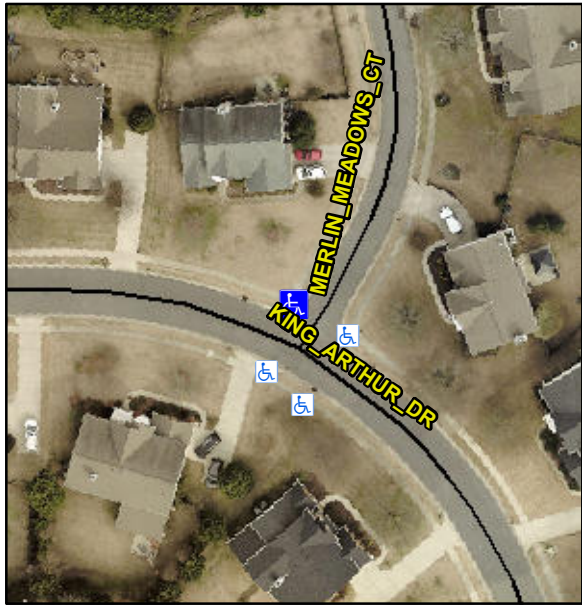
Not Found, R304.2.2, R304.5.3

Compliance		Description	Data	Compliance	Description	Data
N/A	Ramp Length (in)	48.0	No	Ramp Slope (%)	8.5	
Yes	Ramp Width (in)	48.0	No	Ramp XSlope (%)	2.3	
N/A	Flare Type LT	N/A	N/A	Flare Type RT	N/A	
N/A	Flare Slope LT (%)	N/A	N/A	Flare Slope RT (%)	N/A	
N/A	Flare Traversable LT?	N/A	N/A	Flare Traversable RT?	N/A	
N/A	Landing Length (in)	N/A	N/A	DWS Provided?	N/A	
N/A	Landing Width (in)	N/A	N/A	DWS Contrast?	N/A	
N/A	Landing Slope (%)	N/A	N/A	DWS Length (in)	N/A	
N/A	Landing X Slope (%)	N/A	N/A	DWS Full Width?	N/A	
N/A	Landing Curb? (Y/N)	N/A	N/A	DWS Offset (in)	N/A	
N/A	Shared Landing?	N/A				
N/A	Gutter Ponding?	N/A	N/A	Gutter Slope (%)	N/A	
N/A	Gutter Lip Ht (in)	N/A	N/A	Gutter X Slope (%)	N/A	
N/A	Painted X Walk1?	No	N/A	Painted X Walk2?	No	
	X Walk 1 Direction	To SW		X Walk 2 Direction	To SE	
N/A	X Walk 1 Width (in)	N/A	N/A	X Walk 2 Width (in)	N/A	
	X Walk 1 Slope (%)	0.9		X Walk 2 Slope (%)	0.9	
	X Walk 1 X Slope (%)	2.6		X Walk 2 X Slope (%)	3.1

N/A	Ramp inside XWalk1?	N/A	N/A	Ramp inside XWalk2?	N/A	
	Road Slope (%)	3.0	N/A	Clear Space?	N/A	
	Road X Slope (%)	2.3	N/A	Clear Space to XWalk (in)	N/A	
N/A	Any Obstructions?	N/A	N/A	Storm Grate/Utility Hazard?	N/A	
	Obstruction Type			Storm Grate/Utility Type		
		N/A			N/A	
			Yes	Surface Condition? (G/P)	Good

Possible Solutions:

Remove & Replace Curb Ramp With Two New Directional Ramps or Equivalent.
