Access Compliance Report

Public Rights-of-Way

(Curb Ramps)

Intersection ID: 24499	Main Street: BECKMORE_PL	Cross Street: SAINTFIELD_PL	Location: NW
ADA ID: 877D3A57B037	Ramp Type: Perp	Initial Pass/Fail: Fail	Overall Compliance: No
			Severity Score: 13.75

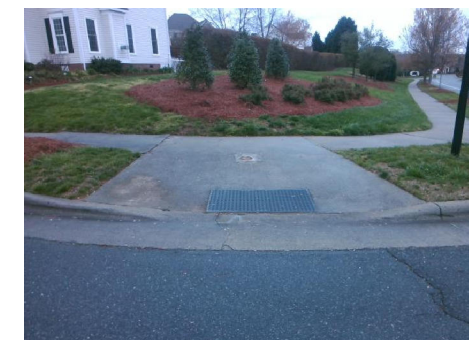
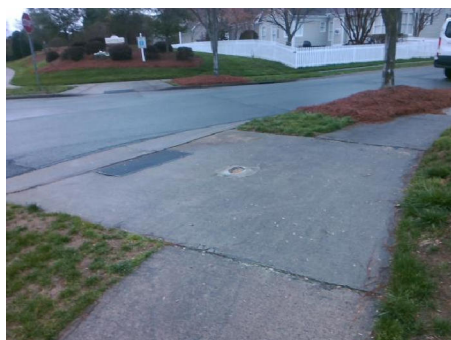
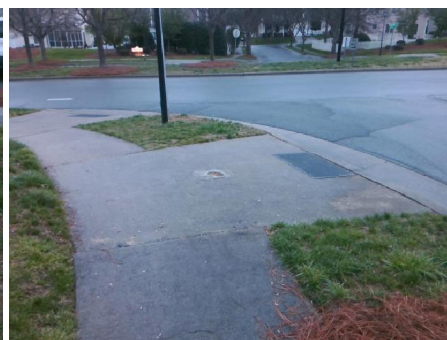
Not Found, R304.2.2, R304.5.3

Compliance	Description	Data	Compliance	Description	Data
N/A	Ramp Length (in)	78.0	No	Ramp Slope (%)	8.6
Yes	Ramp Width (in)	48.0	No	Ramp XSlope (%)	3.3
N/A	Flare Type LT	N/A	N/A	Flare Type RT	N/A
N/A	Flare Slope LT (%)	N/A	N/A	Flare Slope RT (%)	N/A
N/A	Flare Traversable LT?	N/A	N/A	Flare Traversable RT?	N/A
N/A	Landing Length (in)	N/A	N/A	DWS Provided?	N/A
N/A	Landing Width (in)	N/A	N/A	DWS Contrast?	N/A
N/A	Landing Slope (%)	N/A	N/A	DWS Length (in)	N/A
N/A	Landing X Slope (%)	N/A	N/A	DWS Full Width?	N/A
N/A	Landing Curb? (Y/N)	N/A	N/A	DWS Offset (in)	N/A
N/A	Shared Landing?	N/A			
N/A	Gutter Ponding?	N/A	N/A	Gutter Slope (%)	N/A
N/A	Gutter Lip Ht (in)	N/A	N/A	Gutter X Slope (%)	N/A
N/A	Painted X Walk1?	No	N/A	Painted X Walk2?	N/A
	X Walk 1 Direction	To S		X Walk 2 Direction	N/A
N/A	X Walk 1 Width (in)	N/A	N/A	X Walk 2 Width (in)	N/A
	X Walk 1 Slope (%)	3.2		X Walk 2 Slope (%)	N/A
	X Walk 1 X Slope (%)	4.3		X Walk 2 X Slope (%)	N/A

N/A	Ramp inside XWalk1?	N/A	N/A	Ramp inside XWalk2?	N/A
	Road Slope (%)	N/A	N/A	Clear Space?	N/A
	Road X Slope (%)	N/A	N/A	Clear Space to XWalk (in)	N/A
N/A	Any Obstructions?	N/A	N/A	Storm Grate/Utility Hazard?	N/A
	Obstruction Type			Storm Grate/Utility Type	
		N/A			N/A
			Yes	Surface Condition? (G/P)	Good

Remove & Replace Entire Ramp.

Total Cost: \$ 1850.00
