Access Compliance Report Public Rights-of-Way (Curb Ramps)

Intersection ID: N/A Main Street: MATTHEWS FARM LN **Cross Street: WOODBINE WALK RD** Location: NE Initial Pass/Fail: Fail **Overall Compliance: No** ADA ID: 8781093BFF4B Ramp Type: Directional1 **Severity Score:** 1.25

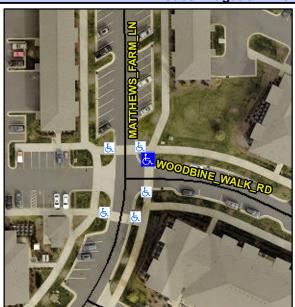
Possible Solution	Field Measurements/Component Compliance				
Possible Solutions:	Compliance Description		Data	Compliance Description	
Remove & Replace Entire Ramp.	N/A	Ramp Length (in)	82.0	N/A	Grade Break?
·	Yes	Ramp Width (in)	91.0	N/A	Grade Break Slope (%)
	Yes	Ramp Slope (%)	6.2	N/A	Grade Break XSlope (%)
	No	Ramp XSlope (%)	4.9		
	N/A	Flare Type LT	N/A	N/A	Flare Type RT
	N/A	Flare Slope LT (%)	N/A	N/A	Flare Slope RT (%)
Surveyor Notes:	N/A	Flare Traversable LT?	N/A	N/A	Flare Traversable RT?
N/A	N/A	Landing Length (in)	0.0	N/A	DWS Provided?
	N/A	Landing Width (in)	0.0	N/A	DWS Contrast?
	N/A	Landing Slope (%)	0.0	N/A	DWS Length (in)
	N/A	Landing X Slope (%)	0.0	N/A	DWS Full Width?
PROW/ADA:	N/A	Landing Curb? (Y/N)	N/A	N/A	DWS Offset LT (in)
R304.5.3	N/A	Shared Landing?	N/A	N/A	DWS Offset RT (in)
	N/A	Gutter Ponding?	0.0	N/A	Gutter Slope (%)
	N/A	Gutter Lip Ht (in)	0.0	N/A	Gutter X Slope (%)
	N/A	Painted X Walk1?	No		Road Slope (%)

X Walk 1 Direction	To S		Road X Slope (%)
		X Walk 1 Width (in)	N/A		Clear Space?
		X Walk 1 Slope (%)	2.5	N/A	Clear Space to XWalk (in)
		X Walk 1 X Slope (%)	1.8	N/A	Storm Grate/Utility Hazard?
	N/A	Ramp inside XWalk1?	N/A		Storm Grate/Utility Type
	N/A	Any Obstructions?	N/A
