# Access Compliance Report

## Public Rights-of-Way

### (Curb Ramps)

Intersection ID: 24356	Main Street: BEVERLY_CREST_BV	Cross Street: CAMAROSS_DR	Location: S
ADA ID: 87812CE5D984	Ramp Type: Perp	Initial Pass/Fail: Fail	Overall Compliance: No
			Severity Score: 8.75

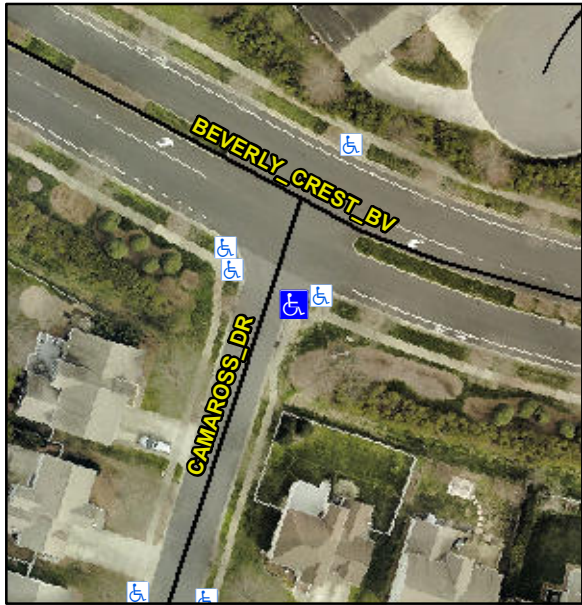
Possible Solutions:		Compliance	Description	Data	Compliance	Description	Data
	Remove & Replace Entire Ramp.		N/A	Ramp Length (in)	91.0	Yes	Ramp Slope (%)	6.7
			No	Ramp Width (in)	46.0	Yes	Ramp XSlope (%)	1.2
			N/A	Flare Type LT	N/A	N/A	Flare Type RT	N/A
			N/A	Flare Slope LT (%)	N/A	N/A	Flare Slope RT (%)	N/A
			N/A	Flare Traversable LT?	N/A	N/A	Flare Traversable RT?	N/A
			N/A	Landing Length (in)	N/A	N/A	DWS Provided?	N/A
			N/A	Landing Width (in)	N/A	N/A	DWS Contrast?	N/A
			N/A	Landing Slope (%)	N/A	N/A	DWS Length (in)	N/A
			N/A	Landing X Slope (%)	N/A	N/A	DWS Full Width?	N/A
Surveyor Notes:			N/A	Landing Curb? (Y/N)	N/A	N/A	DWS Offset (in)	N/A
N/A			N/A	Shared Landing?	N/A			
PROW/ADA:			N/A	Gutter Ponding?	N/A	N/A	Gutter Slope (%)	N/A
Not Found, R304.5.1			N/A	Gutter Lip Ht (in)	N/A	N/A	Gutter X Slope (%)	N/A

N/A	Painted X Walk1?	No	N/A	Painted X Walk2?	N/A
				X Walk 1 Direction	To NW		X Walk 2 Direction	N/A
			N/A	X Walk 1 Width (in)	N/A	N/A	X Walk 2 Width (in)	N/A
				X Walk 1 Slope (%)	0.7		X Walk 2 Slope (%)	N/A
				X Walk 1 X Slope (%)	1.2		X Walk 2 X Slope (%)	N/A
			N/A	Ramp inside XWalk1?	N/A	N/A	Ramp inside XWalk2?	N/A
				Road Slope (%)	N/A	N/A	Clear Space?	N/A
				Road X Slope (%)	N/A	N/A	Clear Space to XWalk (in)	N/A
			N/A	Any Obstructions?	N/A	N/A	Storm Grate/Utility Hazard?	N/A
				Obstruction Type			Storm Grate/Utility Type	
					N/A			N/A
						Yes	Surface Condition? (G/P)	Good
