Access Compliance Report Public Rights-of-Way (Curb Ramps)

Intersection ID: 45130 Main Street: DULIN CREEK BV Cross Street: PLAZA RD EXT Location: NW **Overall Compliance: No** ADA ID: 87883C7B392F Ramp Type: Combination2 Initial Pass/Fail: Fail Severity Score: 33.75

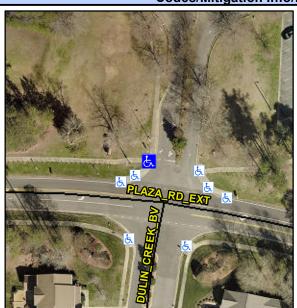
StopSign Street 1 Name **DULIN CREEK BV** Stop Condition-Street 1 N/A Street 2 Name Stop Condition-Street 2 N/A Possible Solutions: Remove & Replace Entire Ramp. Surveyor Notes: LT RP < 5% PROW/ADA: Not Found, R304.5.1, R304.5.3, R304.3.2
