# Access Compliance Report

## Public Rights-of-Way (Curb Ramps)

Intersection ID: 11235	Main Street: CATAWBA_AV	Cross Street: PINCKNEY_AV	Location: NW
ADA ID: 87979B99CC64	Ramp Type: Perp	Initial Pass/Fail: Fail	Overall Compliance: No
		Severity Score: 22.5

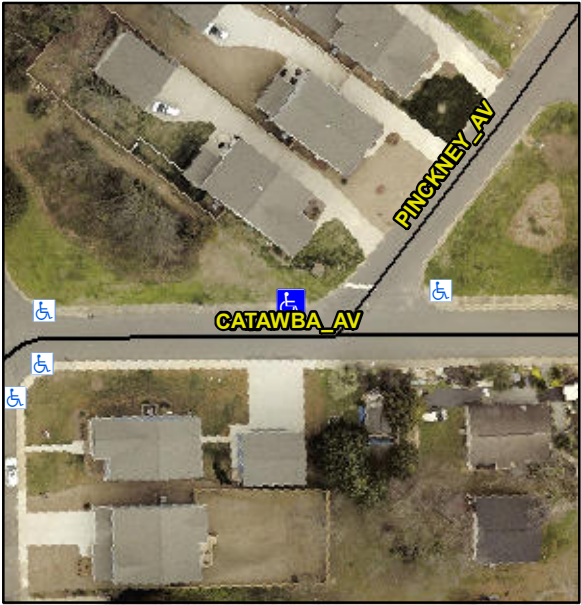
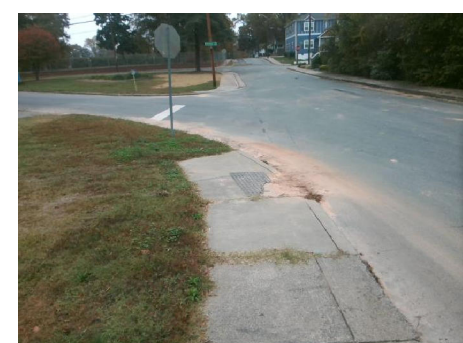
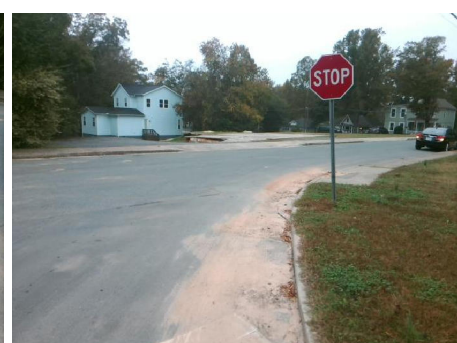
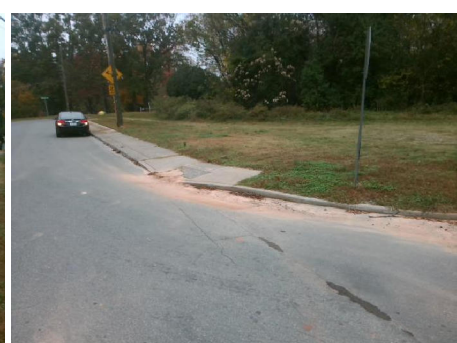
Possible Solutions:		<b>Compliance</b>	<b>Description</b>	<b>Data</b>
	<b>Remove &amp; Replace Entire Ramp.</b>		<b>No</b>	Ramp Length (in)	<b>60.5</b>
			<b>No</b>	Ramp Width (in)	<b>42.0</b>
			<b>N/A</b>	Flare Type LT	<b>N/A</b>
			<b>N/A</b>	Flare Slope LT (%)	<b>N/A</b>
			<b>N/A</b>	Flare Traversable LT?	<b>N/A</b>
			<b>N/A</b>	Landing Length (in)	<b>N/A</b>
			<b>N/A</b>	Landing Width (in)	<b>N/A</b>
			<b>N/A</b>	Landing Slope (%)	<b>N/A</b>
			<b>N/A</b>	Landing X Slope (%)	<b>N/A</b>
<p>Surveyor Notes:</p> <p><b>N/A</b></p> <p>PROW/ADA:</p> <p><b>Not Found, R304.5.1, R304.2.2, R304.5.3</b></p>			<b>N/A</b>	Flare Type RT	<b>N/A</b>
			<b>N/A</b>	Flare Slope RT (%)	<b>N/A</b>
			<b>N/A</b>	Flare Traversable RT?	<b>N/A</b>
			<b>N/A</b>	DWS Provided?	<b>N/A</b>
			<b>N/A</b>	DWS Contrast?	<b>N/A</b>
			<b>N/A</b>	DWS Length (in)	<b>N/A</b>

<b>N/A</b>	DWS Full Width?	<b>N/A</b>
			<b>N/A</b>	DWS Offset (in)	<b>N/A</b>
			<b>N/A</b>	Gutter Ponding?	<b>N/A</b>
			<b>N/A</b>	Gutter Lip Ht (in)	<b>N/A</b>
			<b>No</b>	Painted X Walk1?	<b>N/A</b>
			<b>To E</b>	X Walk 1 Direction	<b>N/A</b>
			<b>N/A</b>	X Walk 1 Width (in)	<b>N/A</b>
			<b>1.7</b>	X Walk 1 Slope (%)	<b>N/A</b>
			<b>5.4</b>	X Walk 1 X Slope (%)	<b>N/A</b>
			<b>N/A</b>	Ramp inside XWalk1?	<b>N/A</b>
			<b>N/A</b>	Road Slope (%)	<b>N/A</b>
			<b>N/A</b>	Road X Slope (%)	<b>N/A</b>
			<b>N/A</b>	Any Obstructions?	<b>N/A</b>
				Obstruction Type	<b>N/A</b>
Total Cost:			<b>\$ 1850.00</b>		
			<b>N/A</b>		<b>N/A</b>
			<b>Yes</b>	Surface Condition? (G/P)	<b>Good</b>
