Access Compliance Report

Public Rights-of-Way

(Curb Ramps)

Intersection ID: 4891	Main Street: GRANARD_LN	Cross Street: PAINTED_PONY_CT	Location: NE
ADA ID: 87A087C41C4D	Ramp Type: Perp	Initial Pass/Fail: Fail	Overall Compliance: No
Severity Score: 12.5			
Codes/Mitigation Info/Possible Solution		Field Measurements/Component Compliance

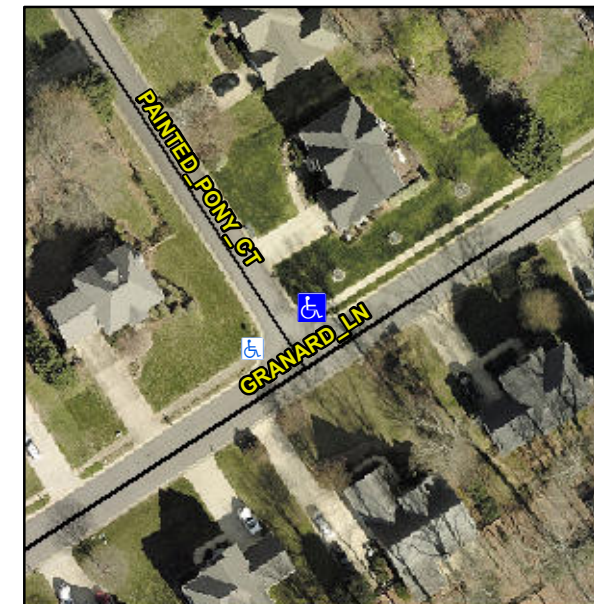
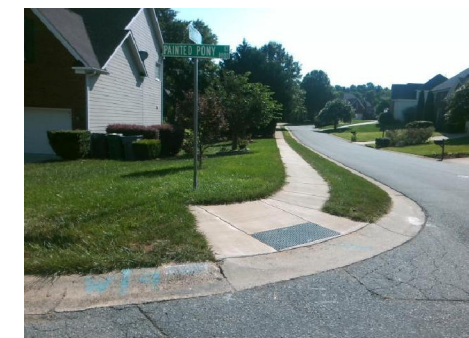
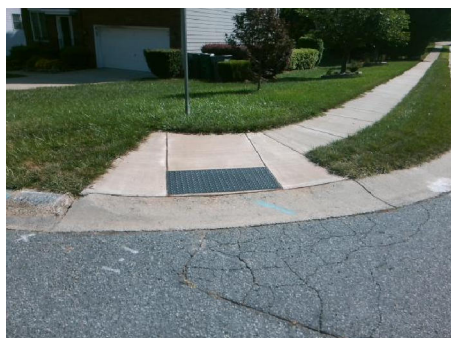
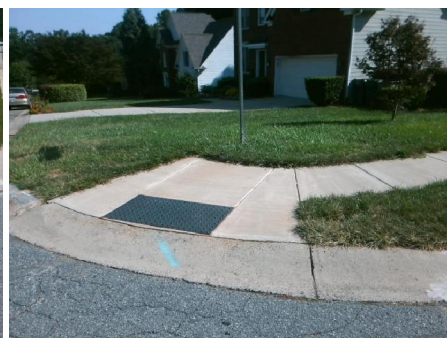
Not Found, R304.2.2

Compliance	Description	Data	Compliance	Description	Data
N/A	Ramp Length (in)	33.0	No	Ramp Slope (%)	8.6
Yes	Ramp Width (in)	48.0	Yes	Ramp XSlope (%)	0.9
N/A	Flare Type LT	N/A	N/A	Flare Type RT	N/A
N/A	Flare Slope LT (%)	N/A	N/A	Flare Slope RT (%)	N/A
N/A	Flare Traversable LT?	N/A	N/A	Flare Traversable RT?	N/A
N/A	Landing Length (in)	N/A	N/A	DWS Provided?	N/A
N/A	Landing Width (in)	N/A	N/A	DWS Contrast?	N/A
N/A	Landing Slope (%)	N/A	N/A	DWS Length (in)	N/A
N/A	Landing X Slope (%)	N/A	N/A	DWS Full Width?	N/A
N/A	Landing Curb? (Y/N)	N/A	N/A	DWS Offset (in)	N/A
N/A	Shared Landing?	N/A			
N/A	Gutter Ponding?	N/A	N/A	Gutter Slope (%)	N/A
N/A	Gutter Lip Ht (in)	N/A	N/A	Gutter X Slope (%)	N/A
N/A	Painted X Walk1?	No	N/A	Painted X Walk2?	N/A
	X Walk 1 Direction	To SW		X Walk 2 Direction	N/A
N/A	X Walk 1 Width (in)	N/A	N/A	X Walk 2 Width (in)	N/A
	X Walk 1 Slope (%)	0.5		X Walk 2 Slope (%)	N/A
	X Walk 1 X Slope (%)	1.9		X Walk 2 X Slope (%)	N/A

N/A	Ramp inside XWalk1?	N/A	N/A	Ramp inside XWalk2?	N/A
	Road Slope (%)	N/A	N/A	Clear Space?	N/A
	Road X Slope (%)	N/A	N/A	Clear Space to XWalk (in)	N/A
N/A	Any Obstructions?	N/A	N/A	Storm Grate/Utility Hazard?	N/A
	Obstruction Type			Storm Grate/Utility Type	
		N/A			N/A
			Yes	Surface Condition? (G/P)	Good

Remove & Replace Entire Ramp.
