# Access Compliance Report

## Public Rights-of-Way

### (Curb Ramps)

Intersection ID: 12620	Main Street: JOHN_CROSLAND_JR_DR	Cross Street: HARGROVE_AV	Location: SW
ADA ID: 87A237C7CFC7	Ramp Type: PerpDiag	Initial Pass/Fail: Fail	Overall Compliance: No
Severity Score: 22.5			
Codes/Mitigation Info/Possible Solution		Field Measurements/Component Compliance

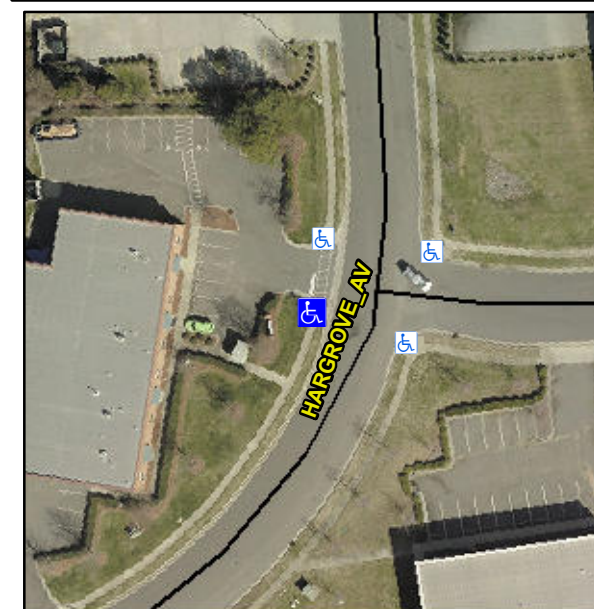
**Not Found, R304.5.1, R304.2.2, R304.5.3**

Compliance	Description	Data	Compliance	Description	Data
N/A	Ramp Length (in)	30.5	No	Ramp Slope (%)	8.9
No	Ramp Width (in)	39.0	No	Ramp XSlope (%)	5.0
N/A	Flare Type LT	N/A	N/A	Flare Type RT	N/A
N/A	Flare Slope LT (%)	N/A	N/A	Flare Slope RT (%)	N/A
N/A	Flare Traversable LT?	N/A	N/A	Flare Traversable RT?	N/A
N/A	Landing Length (in)	N/A	N/A	DWS Provided?	N/A
N/A	Landing Width (in)	N/A	N/A	DWS Contrast?	N/A
N/A	Landing Slope (%)	N/A	N/A	DWS Length (in)	N/A
N/A	Landing X Slope (%)	N/A	N/A	DWS Full Width?	N/A
N/A	Landing Curb? (Y/N)	N/A	N/A	DWS Offset (in)	N/A
N/A	Shared Landing?	N/A			
N/A	Gutter Ponding?	N/A	N/A	Gutter Slope (%)	N/A
N/A	Gutter Lip Ht (in)	N/A	N/A	Gutter X Slope (%)	N/A
N/A	Painted X Walk1?	No	N/A	Painted X Walk2?	Yes
	X Walk 1 Direction	To E		X Walk 2 Direction	To N
N/A	X Walk 1 Width (in)	N/A	N/A	X Walk 2 Width (in)	55.0
	X Walk 1 Slope (%)	3.4		X Walk 2 Slope (%)	1.7
	X Walk 1 X Slope (%)	2.4		X Walk 2 X Slope (%)	4.3

N/A	Ramp inside XWalk1?	N/A	N/A	Ramp inside XWalk2?	Yes
	Road Slope (%)	0.7	N/A	Clear Space?	N/A
	Road X Slope (%)	1.7	N/A	Clear Space to XWalk (in)	N/A
N/A	Any Obstructions?	N/A	N/A	Storm Grate/Utility Hazard?	N/A
	Obstruction Type			Storm Grate/Utility Type	
		N/A			N/A
			Yes	Surface Condition? (G/P)	Good

**Remove & Replace Curb Ramp With Two New Directional Ramps or Equivalent.**
