# Access Compliance Report

## Public Rights-of-Way

### (Curb Ramps)

Intersection ID: 31746	Main Street: WASHOE_PINE_LN	Cross Street: PAPER_BIRCH_DR	Location: NE
ADA ID: 87BCB1EBC41A	Ramp Type: PerpDiag	Initial Pass/Fail: Fail	Overall Compliance: No
Severity Score: 13.75			
Codes/Mitigation Info/Possible Solution		Field Measurements/Component Compliance

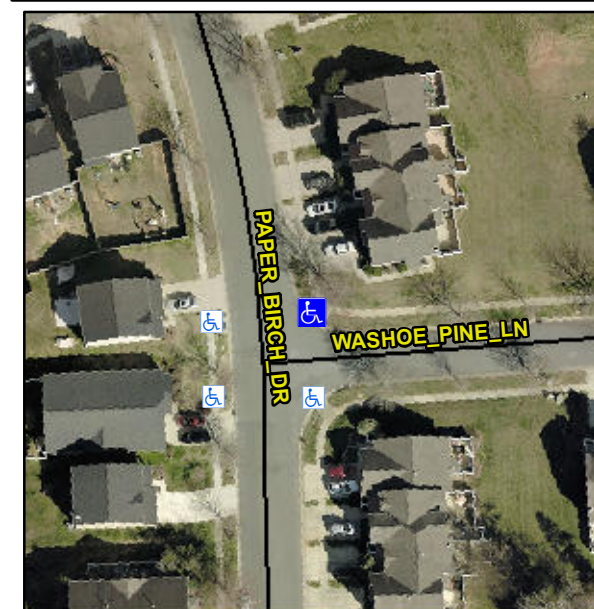
Compliance	Description	Data	Compliance	Description	Data
N/A	Ramp Length (in)	81.5	No	Ramp Slope (%)	10.2
Yes	Ramp Width (in)	48.5	No	Ramp XSlope (%)	4.0
N/A	Flare Type LT	N/A	N/A	Flare Type RT	N/A
N/A	Flare Slope LT (%)	N/A	N/A	Flare Slope RT (%)	N/A
N/A	Flare Traversable LT?	N/A	N/A	Flare Traversable RT?	N/A
N/A	Landing Length (in)	N/A	N/A	DWS Provided?	N/A
N/A	Landing Width (in)	N/A	N/A	DWS Contrast?	N/A
N/A	Landing Slope (%)	N/A	N/A	DWS Length (in)	N/A
N/A	Landing X Slope (%)	N/A	N/A	DWS Full Width?	N/A
N/A	Landing Curb? (Y/N)	N/A	N/A	DWS Offset (in)	N/A
N/A	Shared Landing?	N/A			
N/A	Gutter Ponding?	N/A	N/A	Gutter Slope (%)	N/A
N/A	Gutter Lip Ht (in)	N/A	N/A	Gutter X Slope (%)	N/A
N/A	Painted X Walk1?	No	N/A	Painted X Walk2?	No
	X Walk 1 Direction	To W		X Walk 2 Direction	To S
N/A	X Walk 1 Width (in)	N/A	N/A	X Walk 2 Width (in)	N/A
	X Walk 1 Slope (%)	2.1		X Walk 2 Slope (%)	0.1
	X Walk 1 X Slope (%)	1.1		X Walk 2 X Slope (%)	1.6

N/A	Ramp inside XWalk1?	N/A	N/A	Ramp inside XWalk2?	N/A
	Road Slope (%)	1.9	N/A	Clear Space?	N/A
	Road X Slope (%)	0.6	N/A	Clear Space to XWalk (in)	N/A
N/A	Any Obstructions?	N/A	N/A	Storm Grate/Utility Hazard?	N/A
	Obstruction Type			Storm Grate/Utility Type	
		N/A			N/A
		Yes		Surface Condition? (G/P)	Good

Possible Solutions:

**Remove & Replace Curb Ramp With Two New Directional Ramps or Equivalent.**
