Access Compliance Report

Public Rights-of-Way

(Curb Ramps)

Intersection ID: N/A	Main Street: PERIWINKLE_HILL_CT	Cross Street: N/A	Location: N
ADA ID: 87C020C60C21	Ramp Type: Perp	Initial Pass/Fail: Pass	Overall Compliance: No
Severity Score: 0.25			
Codes/Mitigation Info/Possible Solution		Field Measurements/Component Compliance

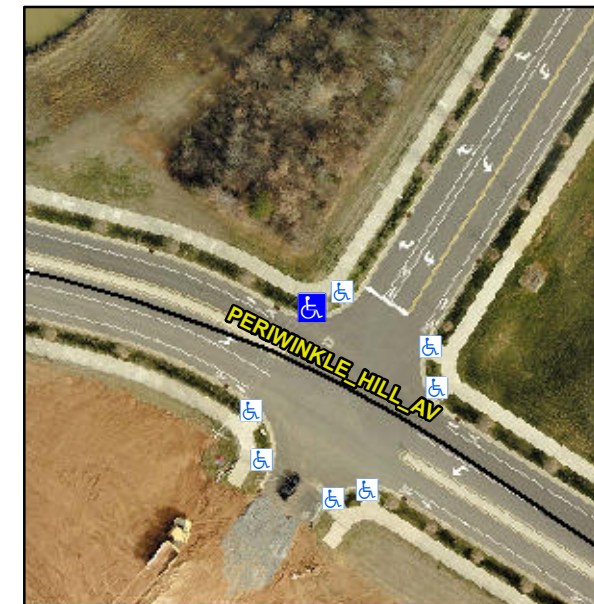
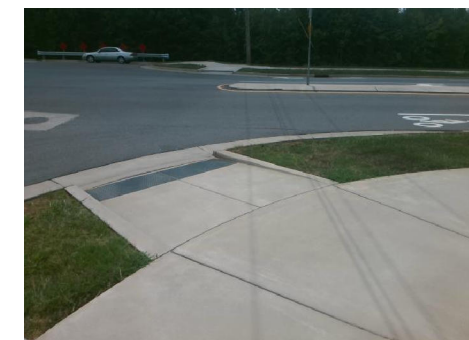
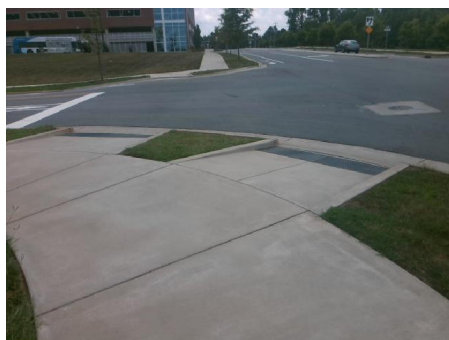
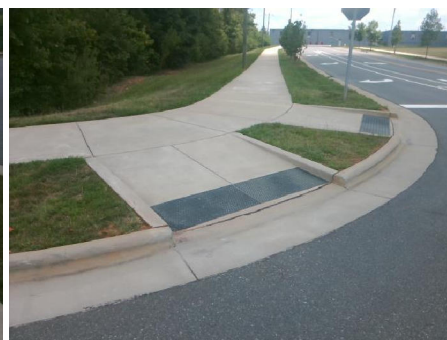
Not Found, R305.2

Compliance	Description	Data	Compliance	Description	Data
N/A	Ramp Length (in)	96.0	Yes	Ramp Slope (%)	8.0
Yes	Ramp Width (in)	93.0	Yes	Ramp XSlope (%)	3.1
Yes	Flare Type L	Curbed_NoWalkSurface	Yes	Flare Type RT	N/A
Yes	Flare Slope LT (%)	N/A	N/A	Flare Slope RT (%)	N/A
N/A	Flare Traversable LT?	No	N/A	Flare Traversable RT?	No
Yes	Landing Length (in)	99.0	Yes	DWS Provided?	Yes
Yes	Landing Width (in)	63.0	Yes	DWS Contrast?	Yes
Yes	Landing Slope (%)	1.3	Yes	DWS Length (in)	24.0
Yes	Landing X Slope (%)	3.5	Yes	DWS Full Width?	Yes
N/A	Landing Curb? (Y/N)	No	No	DWS Offset (in)	4.0
N/A	Shared Landing?	No			
Yes	Gutter Ponding?	No	Yes	Gutter Slope (%)	4.1
Yes	Gutter Lip Ht (in)	0.0	Yes	Gutter X Slope (%)	1.0
N/A	Painted X Walk1?	No	N/A	Painted X Walk2?	N/A
	X Walk 1 Direction	To SW		X Walk 2 Direction	N/A
N/A	X Walk 1 Width (in)	N/A	N/A	X Walk 2 Width (in)	N/A
	X Walk 1 Slope (%)	2.6		X Walk 2 Slope (%)	N/A
	X Walk 1 X Slope (%)	4.3		X Walk 2 X Slope (%)	N/A

N/A	Ramp inside XWalk1?	N/A	N/A	Ramp inside XWalk2?	N/A
	Road Slope (%)	N/A	N/A	Clear Space?	Yes
	Road X Slope (%)	N/A	N/A	Clear Space to XWalk (in)	N/A
Yes	Any Obstructions?	No	Yes	Storm Grate/Utility Hazard?	No
	Obstruction Type			Storm Grate/Utility Type	
		N/A			N/A
			Yes	Surface Condition? (G/P)	Good

Remove & Replace Entire Ramp.
