Access Compliance Report

Public Rights-of-Way

(Curb Ramps)

| Intersection ID: 12299 | Main Street: W_MOREHEAD_ST | Cross Street: S_CHASE_ST | Location: E |

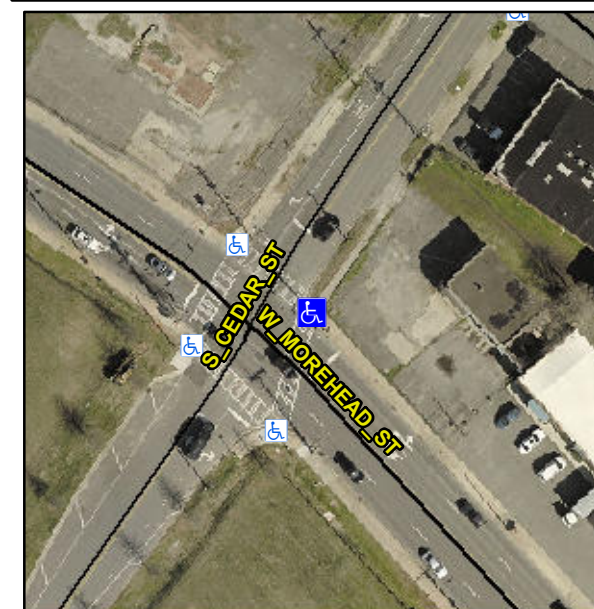
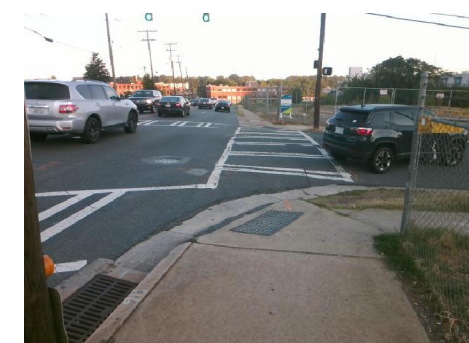
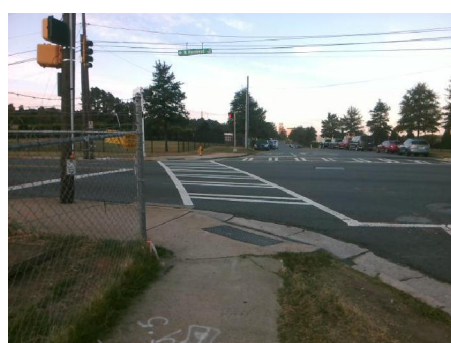
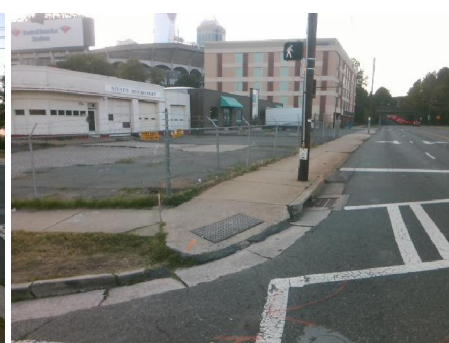
Not Found, R304.2.2, R304.5.3

| Compliance | Description | Data | Compliance | Description | Data |
|---|---|---|---|---|---|
| N/A | Ramp Length (in) | 64.0 | No | Ramp Slope (%) | 9.0 |
| Yes | Ramp Width (in) | 48.0 | No | Ramp XSlope (%) | 7.0 |

Remove & Replace Curb Ramp With Two New Directional Ramps or Equivalent.
