# Access Compliance Report

## Public Rights-of-Way

### (Curb Ramps)

| Intersection ID: 15605 | Main Street: GREYSTONE_RD | Cross Street: SOUTH_BV | Location: SE |

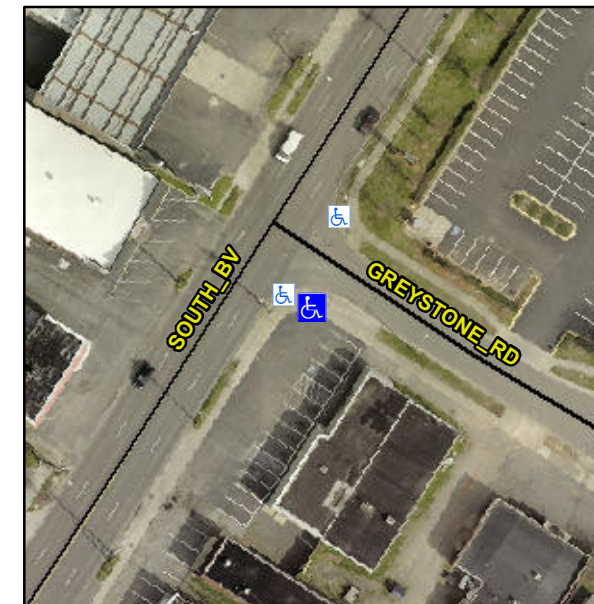
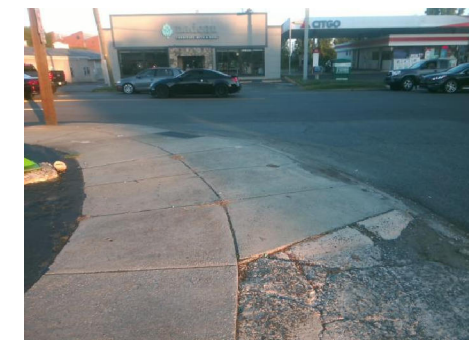
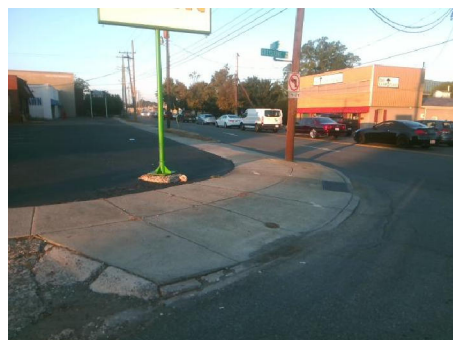
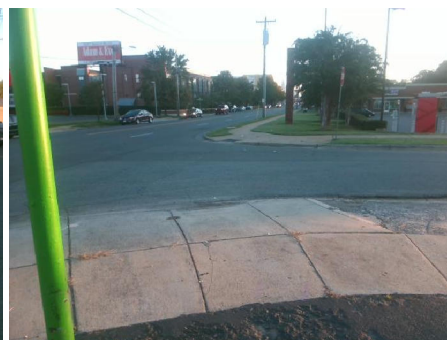
| ADA ID: 87C54B9A898D | Ramp Type: Perp | Initial Pass/Fail: Fail | Overall Compliance: No |
| | | Severity Score: 25 | |

**Not Found, R304.2.2**

| Compliance | Description | Data | Compliance | Description | Data |
|---|---|---|---|---|---|
| N/A | Ramp Length (in) | 77.0 | No | Ramp Slope (%) | 14.2 |

**Remove & Replace Entire Ramp.**

Total Cost: \$ 1850.00
