Access Compliance Report

Public Rights-of-Way

(Curb Ramps)

Intersection ID: 49920	Main Street: AUSTIN_DEKOTA_DR	Cross Street: WANAMASSA_DR	Location:	N
ADA ID: 87D3FCE06B3A	Ramp Type: BlendTrans1	Initial Pass/Fail: Fail	Overall Compliance: No	Severity Score: 8.75
Codes/Mitigation Info/Possible Solution		Field Measurements/Component Compliance

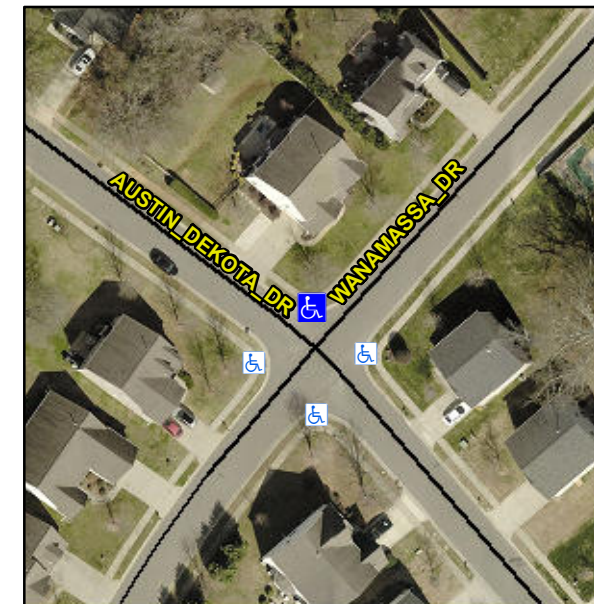
Not Found, R304.5.1

Compliance	Description	Data	Compliance	Description	Data
N/A	Ramp Length (in)	48.0	Yes	BlendTrans Slope (%)	2.3
No	Ramp Width (in)	46.0	Yes	BlendTrans XSlope (%)	1.0
N/A	Flare Type LT	N/A	N/A	Flare Type RT	N/A
N/A	Flare Slope LT (%)	N/A	N/A	Flare Slope RT (%)	N/A
N/A	Flare Traversable LT?	N/A	N/A	Flare Traversable RT?	N/A
N/A	Landing Length (in)	N/A	N/A	DWS Provided?	N/A
N/A	Landing Width (in)	N/A	N/A	DWS Contrast?	N/A
N/A	Landing Slope (%)	N/A	N/A	DWS Length (in)	N/A
N/A	Landing X Slope (%)	N/A	N/A	DWS Full Width?	N/A
N/A	Landing Curb? (Y/N)	N/A	N/A	DWS Offset (in)	N/A
N/A	Shared Landing?	N/A			
N/A	Gutter Ponding?	N/A	N/A	Gutter Slope (%)	N/A
N/A	Gutter Lip Ht (in)	N/A	N/A	Gutter X Slope (%)	N/A
N/A	Painted X Walk1?	No	N/A	Painted X Walk2?	No
	X Walk 1 Direction	To W		X Walk 2 Direction	To E
	X Walk 1 Width (in)	N/A		X Walk 2 Width (in)	N/A
	X Walk 1 Slope (%)	1.7		X Walk 2 Slope (%)	2.0
	X Walk 1 X Slope (%)	1.4		X Walk 2 X Slope (%)	1.2

N/A	Ramp inside XWalk1?	N/A	N/A	Ramp inside XWalk2?	N/A
	Road Slope (%)	1.6		Clear Space?	N/A
	Road X Slope (%)	0.3	N/A	Clear Space to XWalk (in)	N/A
N/A	Any Obstructions?	N/A	N/A	Storm Grate/Utility Hazard?	N/A
	Obstruction Type			Storm Grate/Utility Type	
		N/A			N/A
			Yes	Surface Condition? (G/P)	Good
			No	Curb Slope (%)	16.0

Remove & Replace Curb Ramp With Two New Directional Ramps or Equivalent.
