Access Compliance Report

Public Rights-of-Way

(Curb Ramps)

Intersection ID: 20264	Main Street: DINGESS_RD	Cross Street: MEADHAVEN_DR	Location: NW
ADA ID: 87DDF849E619	Ramp Type: PerpDiag	Initial Pass/Fail: Fail	Overall Compliance: No
Severity Score: 22.5			
Codes/Mitigation Info/Possible Solution		Field Measurements/Component Compliance

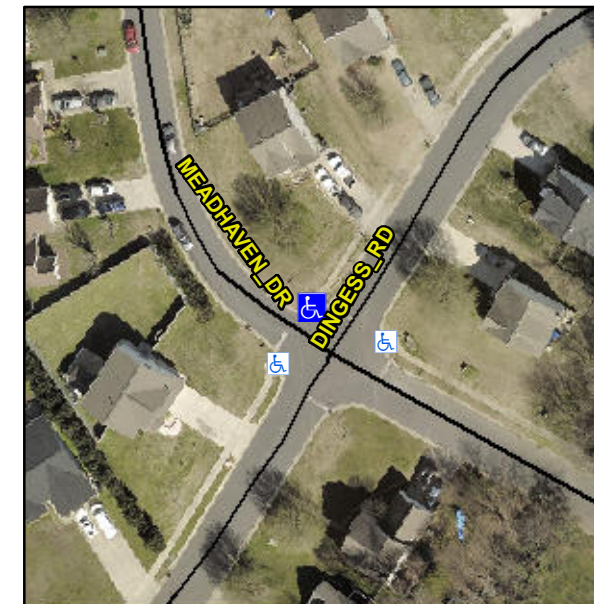
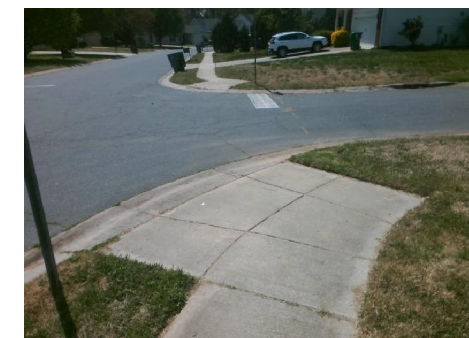
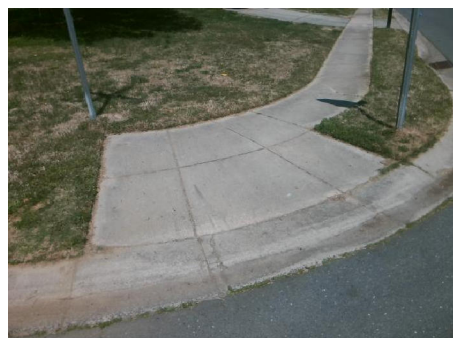
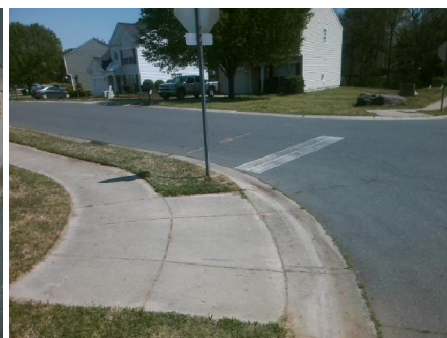
Compliance	Description	Data	Compliance	Description	Data
N/A	Ramp Length (in)	45.0	No	Ramp Slope (%)	11.3
No	Ramp Width (in)	41.0	No	Ramp XSlope (%)	2.7
N/A	Flare Type LT	N/A	N/A	Flare Type RT	N/A
N/A	Flare Slope LT (%)	N/A	N/A	Flare Slope RT (%)	N/A
N/A	Flare Traversable LT?	N/A	N/A	Flare Traversable RT?	N/A
N/A	Landing Length (in)	N/A	N/A	DWS Provided?	N/A
N/A	Landing Width (in)	N/A	N/A	DWS Contrast?	N/A
N/A	Landing Slope (%)	N/A	N/A	DWS Length (in)	N/A
N/A	Landing X Slope (%)	N/A	N/A	DWS Full Width?	N/A
N/A	Landing Curb? (Y/N)	N/A	N/A	DWS Offset (in)	N/A
N/A	Shared Landing?	N/A			
N/A	Gutter Ponding?	N/A	N/A	Gutter Slope (%)	N/A
N/A	Gutter Lip Ht (in)	N/A	N/A	Gutter X Slope (%)	N/A
N/A	Painted X Walk1?	No	N/A	Painted X Walk2?	No
	X Walk 1 Direction	To SW		X Walk 2 Direction	To SE
N/A	X Walk 1 Width (in)	N/A	N/A	X Walk 2 Width (in)	N/A
	X Walk 1 Slope (%)	0.6		X Walk 2 Slope (%)	1.3
	X Walk 1 X Slope (%)	1.2		X Walk 2 X Slope (%)	0.1

N/A	Ramp inside XWalk1?	N/A	N/A	Ramp inside XWalk2?	N/A
	Road Slope (%)	0.6	N/A	Clear Space?	N/A
	Road X Slope (%)	0.2	N/A	Clear Space to XWalk (in)	N/A
N/A	Any Obstructions?	N/A	N/A	Storm Grate/Utility Hazard?	N/A
	Obstruction Type			Storm Grate/Utility Type	
		N/A			N/A
			Yes	Surface Condition? (G/P)	Good

Remove & Replace Curb Ramp With Two New Directional Ramps or Equivalent.

R304.5.1, R304.2.2, R304.5.3
