## Access Compliance Report Public Rights-of-Way (Curb Ramps)

Intersection ID: 15322 Main Street: CRANBROOK\_LN Cross Street: RANDOLPH\_RD Location: NE

ADA ID: 87E38907B02A Ramp Type: PerpDiag Initial Pass/Fail: Fail Overall Compliance: No Severity Score: 12.5

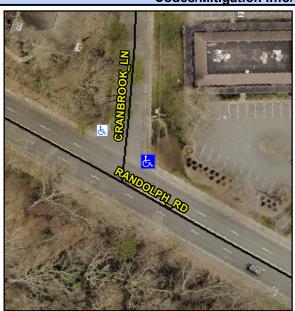
Compliance Description Data Compliance Description Data No Ramp Slope (%) N/A Ramp Length (in) 58.0 9.6 Yes Ramp XSlope (%) Yes Ramp Width (in) 48.0 0.9 N/A N/A Flare Type LT N/A Flare Type RT N/A N/A Flare Slope LT (%) N/A N/A Flare Slope RT (%) N/A N/A Flare Traversable LT? N/A N/A Flare Traversable RT? N/A N/A N/A N/A **DWS Provided?** N/A Landing Length (in) N/A Landing Width (in) N/A N/A **DWS Contrast?** N/A N/A N/A N/A Landing Slope (%) DWS Length (in) N/A N/A Landing X Slope (%) N/A N/A DWS Full Width? N/A N/A Landing Curb? (Y/N) N/A N/A DWS Offset (in) N/A N/A N/A Shared Landing? N/A Gutter Ponding? N/A N/A Gutter Slope (%) N/A N/A Gutter Lip Ht (in) N/A N/A Gutter X Slope (%) N/A N/A Painted X Walk1? No N/A Painted X Walk2? No X Walk 1 Direction To NW X Walk 2 Direction To SW N/A N/A N/A X Walk 1 Width (in) X Walk 2 Width (in) N/A X Walk 1 Slope (%) 7.0 X Walk 2 Slope (%) 10.6 X Walk 1 X Slope (%) 6.8 X Walk 2 X Slope (%) 2.4 N/A N/A N/A Ramp inside XWalk2? N/A Ramp inside XWalk1? Road Slope (%) 2.3 N/A Clear Space? N/A N/A Road X Slope (%) 8.7 Clear Space to XWalk (in) N/A N/A N/A Any Obstructions? N/A Storm Grate/Utility Hazard? N/A

Remove & Replace Curb Ramp With
Two New Directional Ramps or
Equivalent.

Not Found, R304.2.2
